**Investigation Report on  
Prestressing Tendon Failure Incident at  
Concrete Viaduct of Shenzhen Bay Bridge  
- Hong Kong Section**

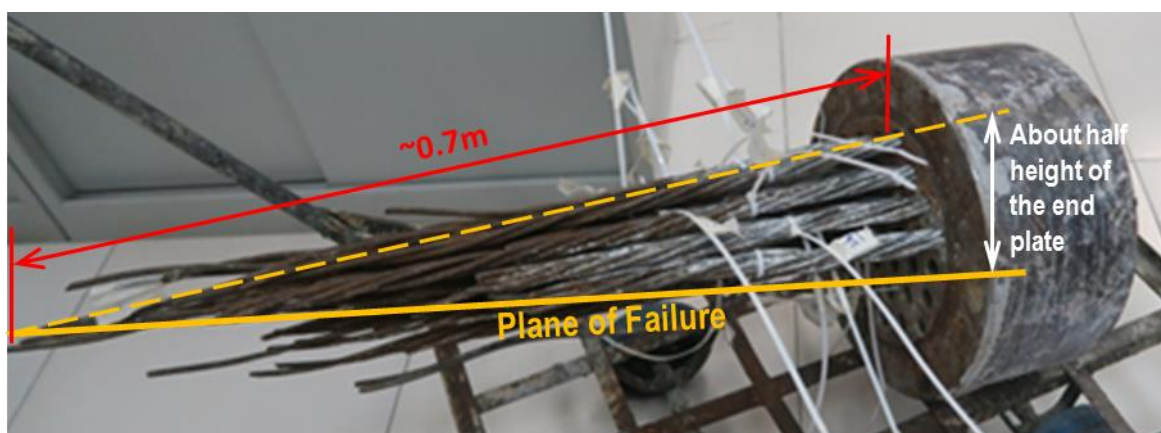
- (i) The steel strands at anchor head P5 had failed along a plane from the top at approximately 0.7 metre from the anchor head to about half height of the end plate as shown in Figure 11. The strands at the lower half had mainly failed by tension at the anchor head. Signs of corrosion were found on most of the wires at the upper half of the anchor head but not for those at the lower half that were totally embedded in the grout encasing the tendon along its length.

Figure 11 General view of broken strands at anchor head P5

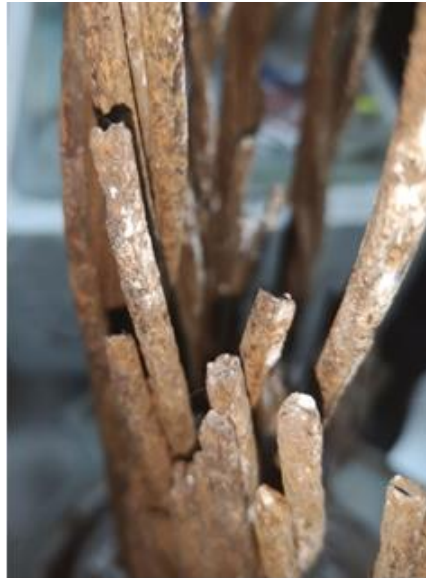
- (ii) The steel strands at the upper half of anchor head P5 exhibited signs of serious corrosion with significant reduction in cross-section, and some of the fracture zones had corroded steel areas to the extent of forming

sharp end features. Twelve steel wires with serious corrosion were examined more thoroughly in SEM to characterise their nature of failure. Despite the serious corrosion, the fracture surfaces on all samples examined exhibited typical dimple features that are characteristics of ductile tensile overload failure. An analysis of the chemical species by an EDAX at the interface between the corroded surface and base metal also revealed no signs of any aggressive elements.

**Figure 12 Broken strands with significant reduction in cross section**

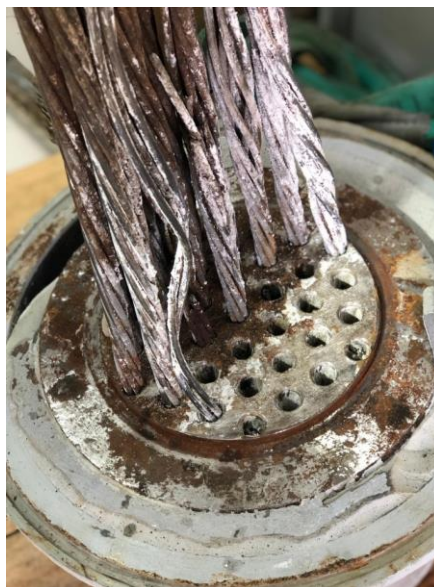
- (iii) The steel strands at the lower half of anchor head P5 did not reveal any significant sign of corrosion. The failure of these strands was mostly due to pulling out of wires from the anchor head with the surrounding wires ruptured due to ductile tensile overload failure.

**Figure 13 Ruptured wires pulled out from anchor head**

- 3.1.3 White powdery paste (as shown in Figure 13), a product of grout bleeding, was observed at the end of tendon strands near anchor head P5 except the part of tendon strands subject to corrosion.
- 3.1.4 The Investigation Team also inspected the steel strands at anchor head P1. It was observed from the strands directly adjacent to the anchor block that the surfaces of the strands were all covered uniformly by whitish cementitious material and all the exposed strands basically exhibited no sign of corrosion.

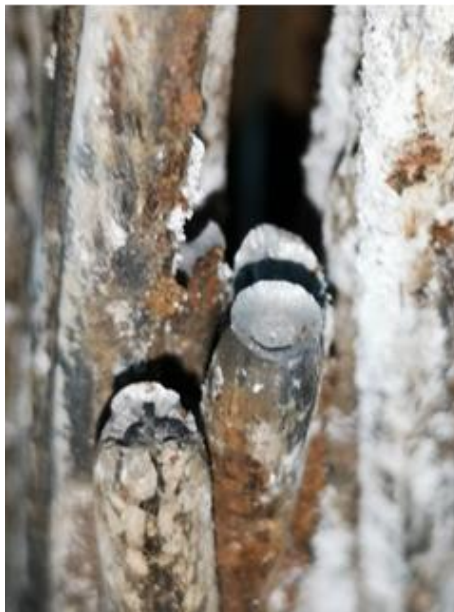
- (iv) The steel strands in between the upper and lower halves of anchor head P5 showed signs of slight to moderate corrosion. However, the corrosion appeared to be superficial and did not result in significant reduction of the cross-section of the wires. Most of the ruptured wires exhibited ductile tensile failure with cup-and-cone features. The final fracture surface of all wires yielded dimple features when examined at very high magnification using a SEM. The dimples are characteristic of ductile failure and indicate that corrosion had not caused any embrittlement of the wires. All tension failures of the strands were ductile in nature. No evidence of any shear type failure existed.

**Figure 14 Broken corroded wires with cup-and-cone failure feature**

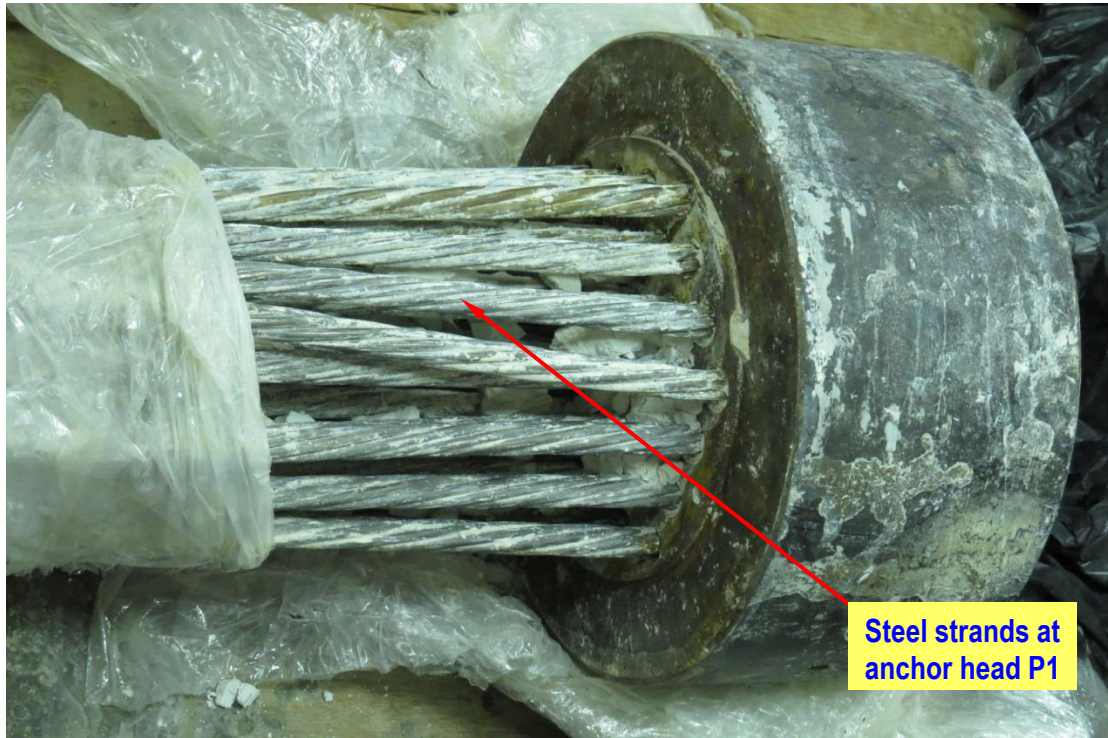
Figure 15 Condition of steel strands at anchor head P1 (with embedded grouts removed)

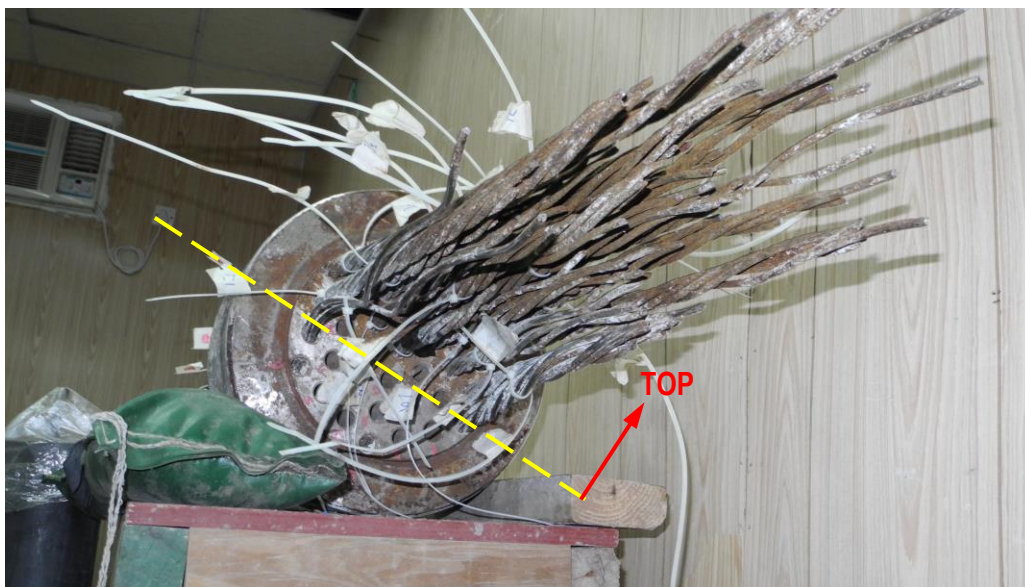
3.1.5 As shown in Figure 16, sign of rust was found at the upper half of the inner surface of the end plate at the anchor head P5, whereas the lower half of the inner surface contains some whitish powders of grout materials without any corrosion.

Figure 16 Condition of the inner surface of the end plate at anchor head P5

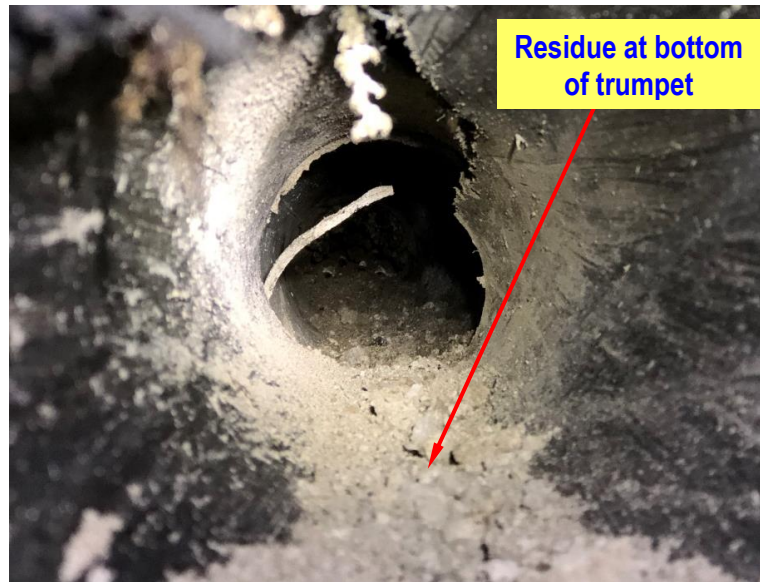
3.1.6 It is observed from the remains of the broken trumpet of anchor head P5 that a layer of residue had accumulated at the bottom of the trumpet. SEM analysis of the residue material revealed that the residue was basically a mix of dirt and iron powder, which was suspected to be left after the strand installation and stressing operation.

**Figure 17 Residue found at the bottom of trumpet at anchor head P5**

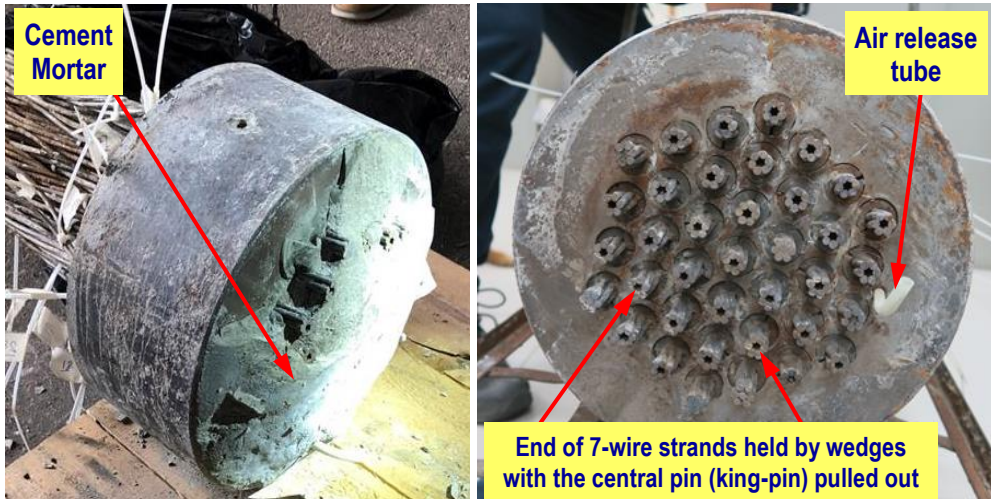
3.1.7 The wedges of anchor head P5 were found rendered with cement mortar to seal the wedge cavities while leaving a plastic tube (comprising two sections of tubes in difference sizes: the outer section connecting to the anchor protection cap is of 15mm outer diameter with 8mm inner diameter, and the inner section connecting through the end plate to the trumpet interior is of 8mm outer diameter with 5mm inner diameter) which was supposed to be an air release tube for expelling air trapped in the trumpet area during grouting.

**Figure 18 (Left) Anchor head P5 rendered with cement mortar;  
(Right) P5 wedge area after removal of mortar with the air release tube exposed**

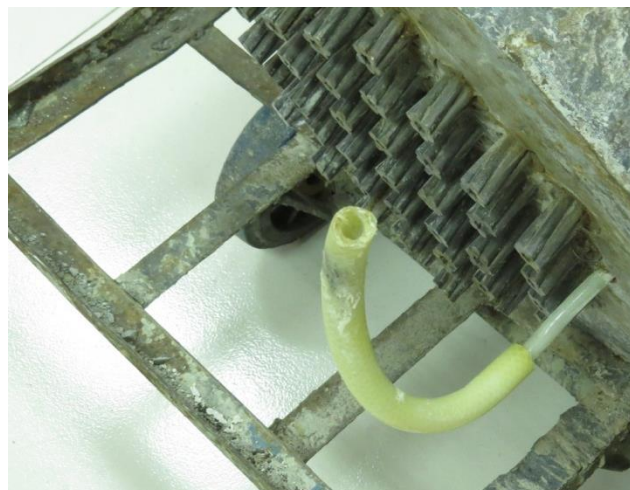
3.1.8 The Investigation Team further examined the air release tube at anchor head P5. It was observed that it was not filled with grout but traces of residue were observed inside the smaller tube. The residue inside the tube had a similar morphology to the grout at the interface of the air void and bleed-zone. This grout had clearly been effected with a high water/cement ratio from the bleed water and the possible residual water from the pressure test conducted on the duct prior to stressing of the tendon. The excess water would have accumulated at the head of the grout as the grout proceeded through the duct up into the trumpet area of the anchorage. SEM analysis revealed that this residue also contained dirt and iron powder identical to that found at the bottom of the trumpet.

**Figure 19 Air release tube at anchor head P5**

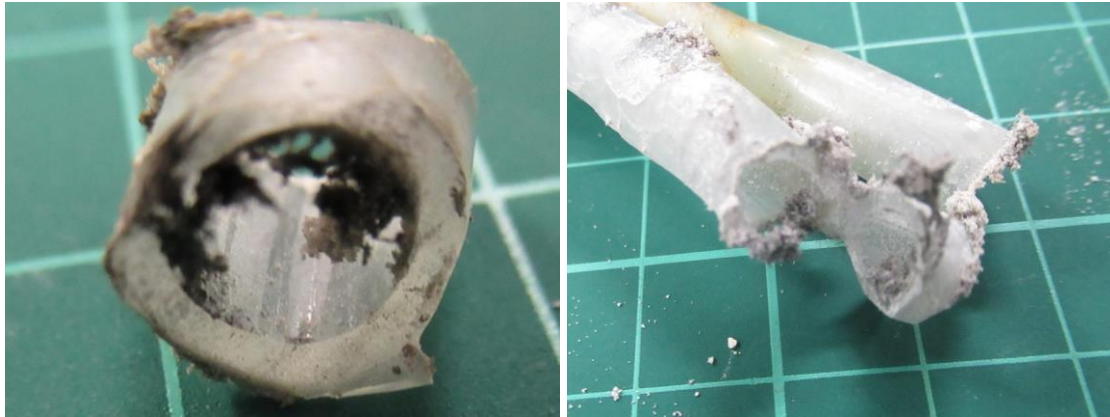
**Figure 20 Trace of residue within air release tube at anchor head P5**

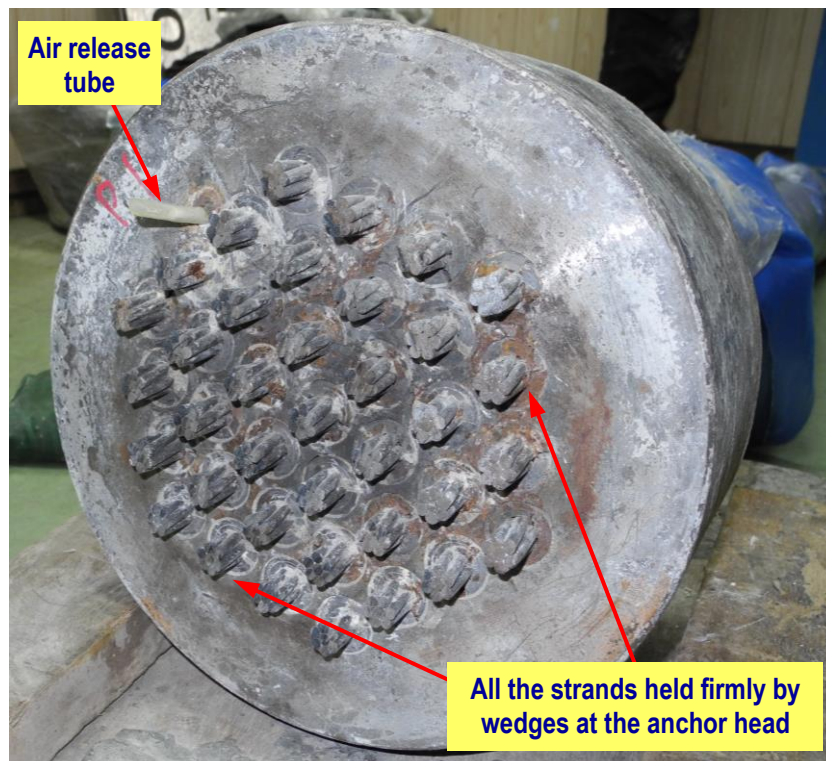
3.1.9 No sign of corrosion was found at the inner surface of anchor head P1 as shown in Figure 21. The wedges were also found in good condition to hold the steel strands firmly.

**Figure 21 Condition of wedges at anchor head P1**

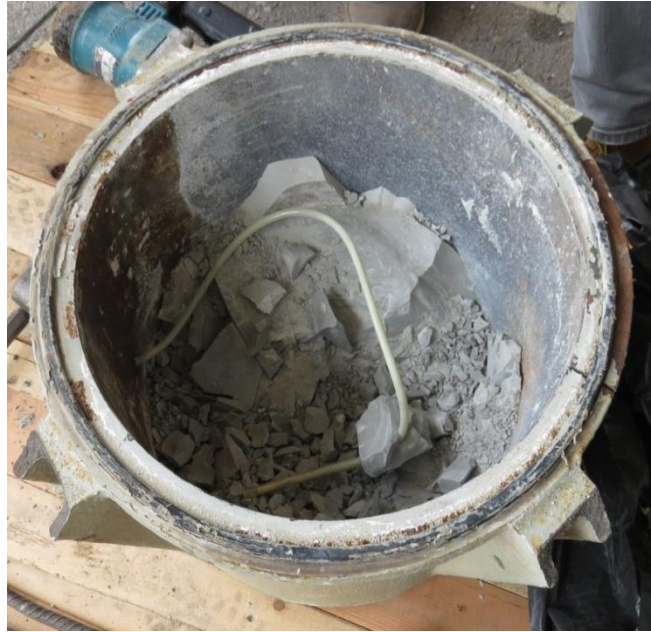
3.1.10 An inspection to the air release tube at anchor head P1 revealed that it was partially filled with cementitious grout.

**Figure 22 Condition of the air release tube at the cap of anchor head P1**

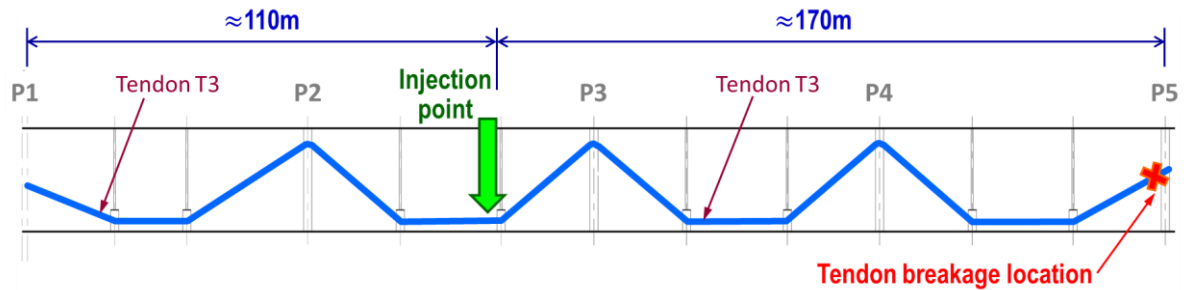
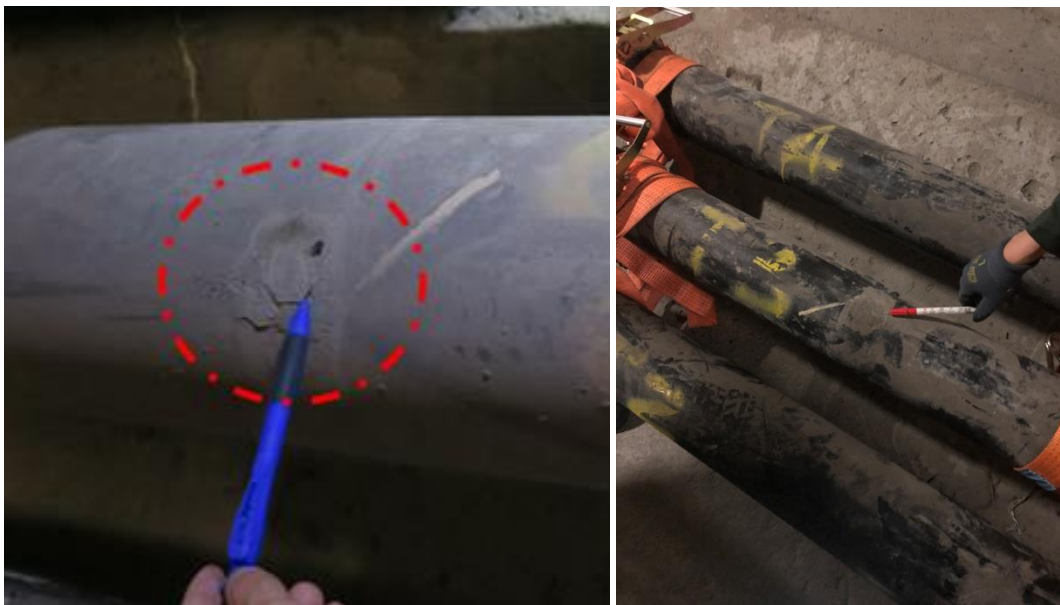
3.3.6 Based on the trace of grout injection points left on the other tendons and VSL's advice provided after a joint site inspection with the Investigation Team, the Investigation Team considered that the grout injection point for Tendon T3 was located at the low point in-between Piers P2 and P3. Such grout injection point was located at about 110m from anchor head P1 which is at about 170m from anchor head P5 (See Figure 24 below).

**Figure 24 (Left) Grout Injection Point observed on ruptured Tendon T3; (Right) Trace of grout injection points of tendons on symmetrical parallel side**

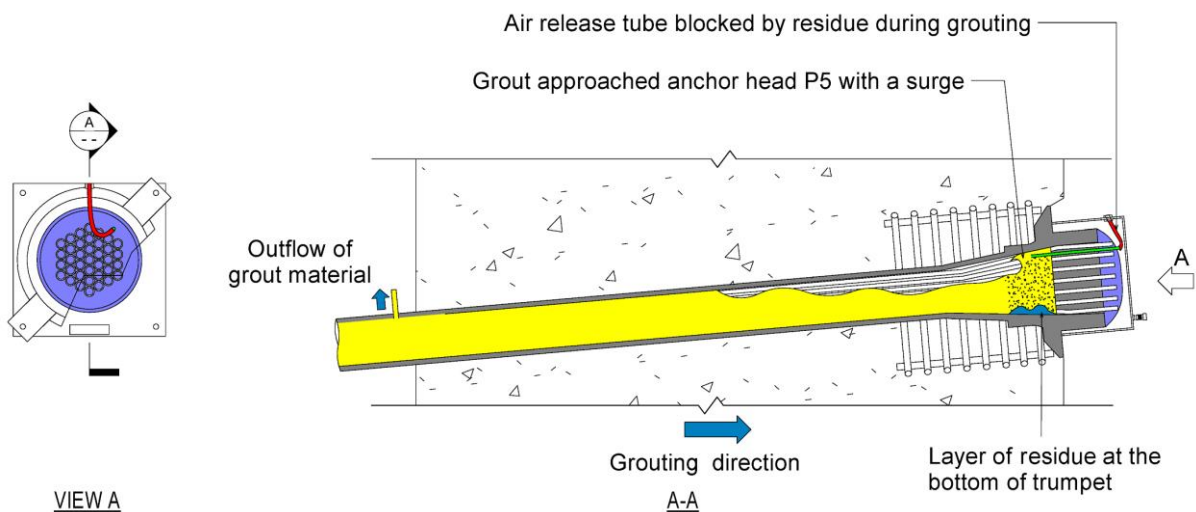
- (i) Sequence 8A (Estimated Condition) – When the grout was approaching anchor head P5 with the surge, and the residue at the bottom of the trumpet was flushed up into the air release tube due to grout surge phenomenon.

**Figure 35 Sequence 8A – Grout approached anchor head P5 with a surge (Estimated Condition)**

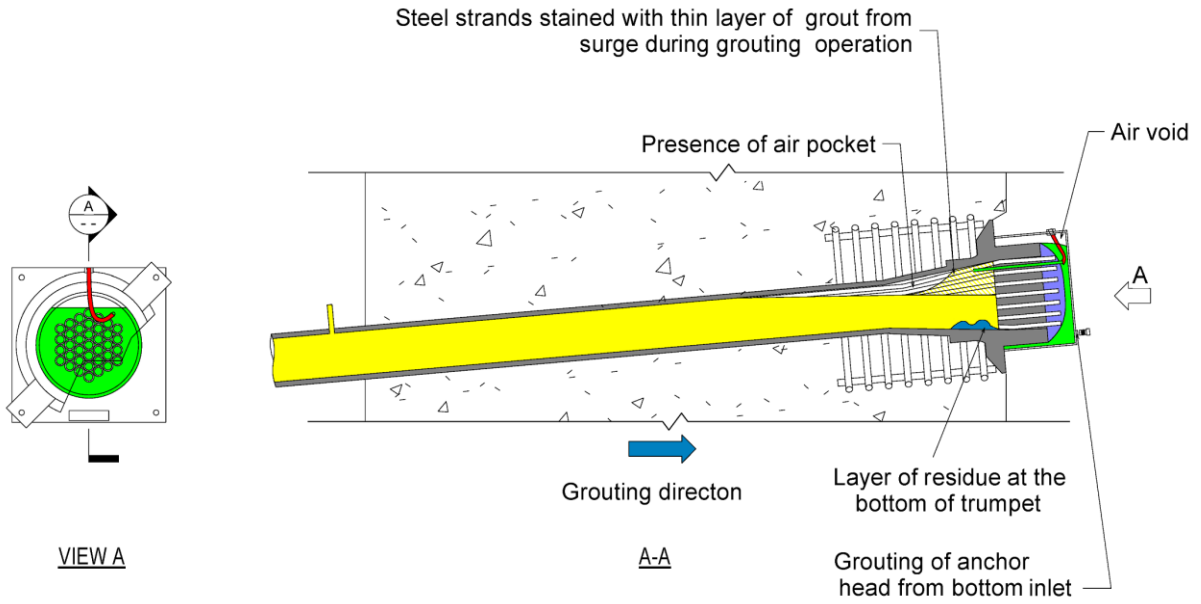
- (ii) Sequence 9A (Estimated Condition) – As indicated in paragraph 3.1.8, the air release tube was not filled with grout but trace of residue was observed inside the tube. The residue was considered to partially block the air release tube during the grouting process. As the nearest grout vent was located outside the diaphragm wall, the grouting operation stopped when the 5-litre of grout had been received at this grout vent while the air pocket at the trumpet area was yet to be filled. The protection cap of the anchor was subsequently filled up by grout under a separate operation.

**Figure 36 Sequence 9A – Grouting operation stopped and anchor protection cap subsequently filled up by grout (Estimated Condition)**

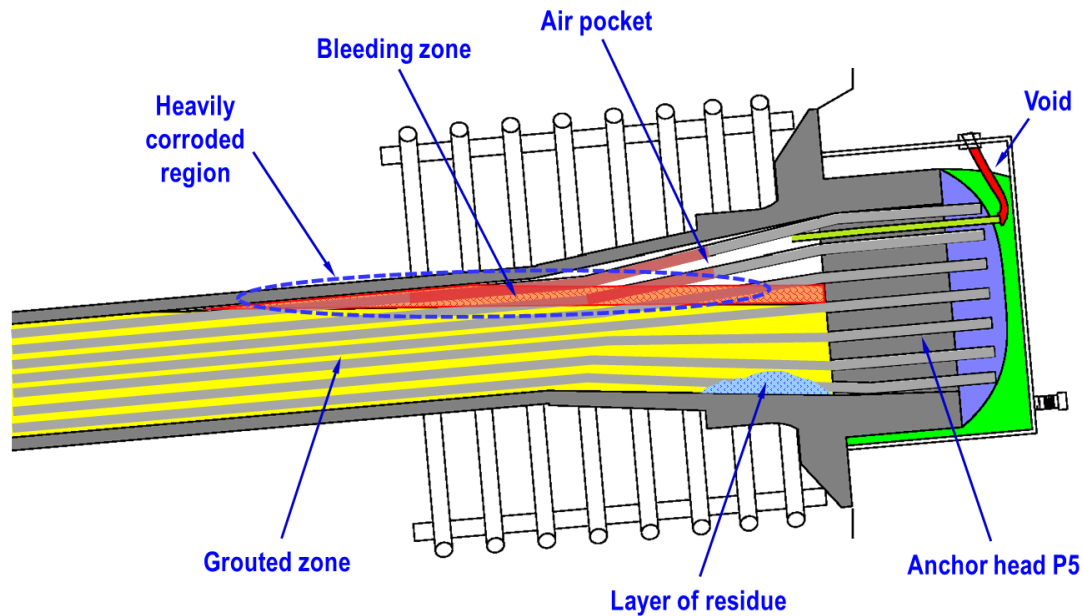
- 4.1.3 As indicated in Figure 37, with the inclination of the tendon profile and the anchorage at the high end point of the tendon T3 profile, a grout interface existed at a level approximately at the mid-height of the anchor through which the strands were held by the wedges. This interface between the top of the grout and the air pocket was a region where the bleed water from the grout accumulated.

**Figure 37 Corrosion development on steel strands of tendon T3 near anchor head P5 at the voided region with free-water from bleeding and trapped air pocket**

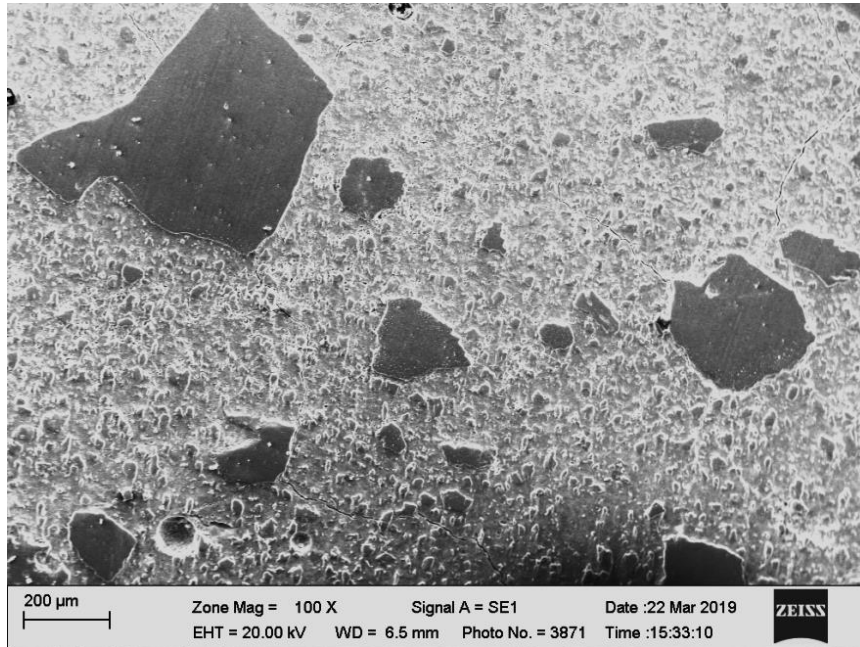
**Sample #2:** Sample from the end cap at P5, retrieved from the anchor body  
 A piece of sample from P5 Cap shows very different structure. This contained very large particles that are likely constituent of cement mortar. The matrix was simply Calcium rich cementitious material (Spectrum 30 & 31) and the large particles sands in the mortar.
