## **Annex C - Drainage Impact Assessment (DIA) of Garden Road and Cotton Tree Drive**

There are two key components in the DIA of a road. First is to investigate whether there are any additional lateral or upstream inflows to the road and to provide interception roadside channels or inlets to prevent them flowing onto the road. Second is to assess the adequacy of the existing drainage facilities of the road and check them with reference to RD/GN/035. Garden road and Cotton Tree Drive are used as a study case and the steps of analysis are shown below.

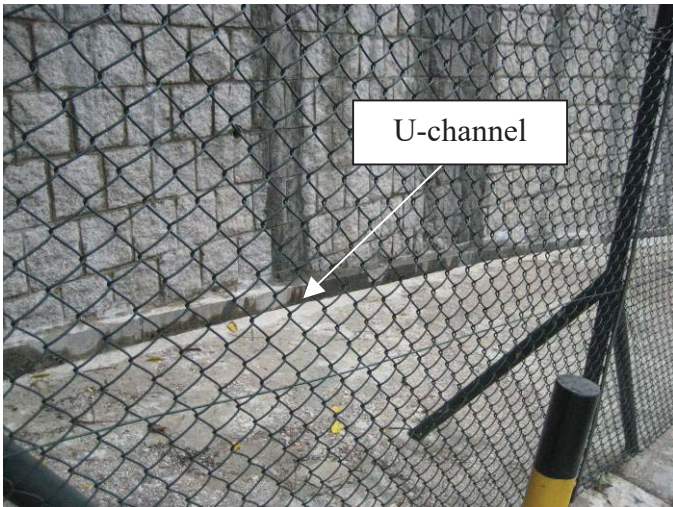
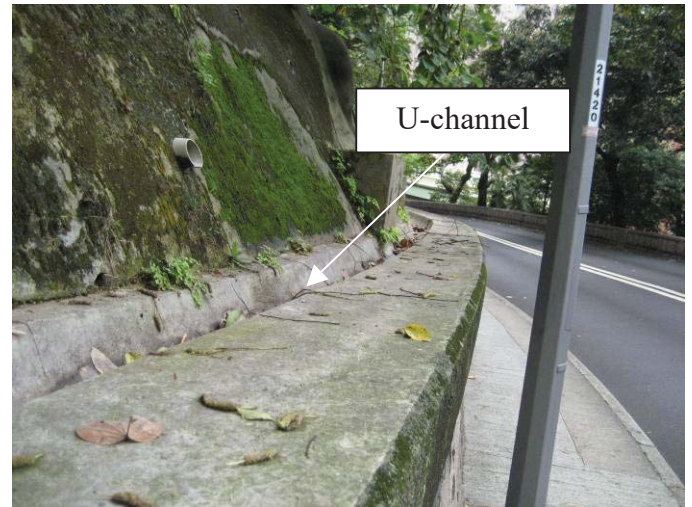
Note 1

As there is an interception channel along the toe of slope, it is expected that the stormwater runoff in Area C1 will not run onto the road pavement.

Interception channel along slope toe

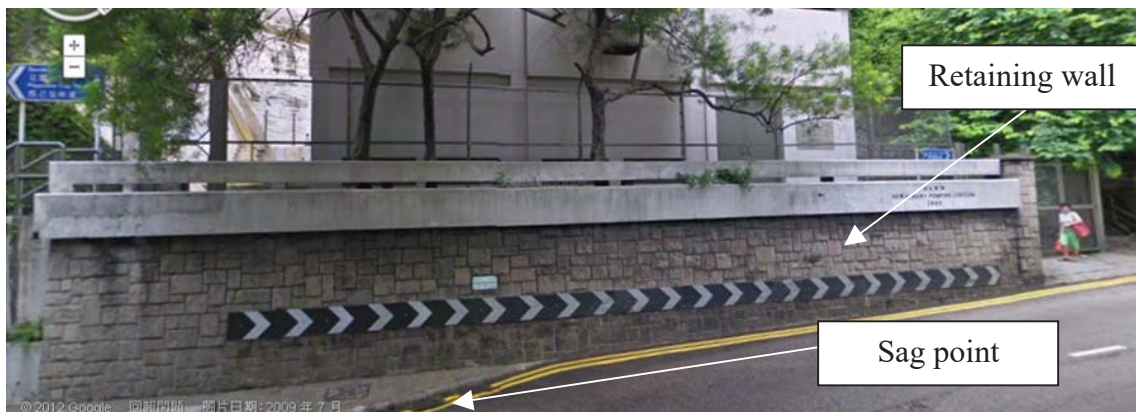
Note 2

There is a retaining wall at the toe of slope. It is expected that the stormwater runoff in Area C2 will likely be blocked by the retaining wall and will not run onto the road pavement. Besides, there is a sag point at the road section immediately next to the retaining wall and six gullies are provided at there.

Retaining wall and multiple gullies

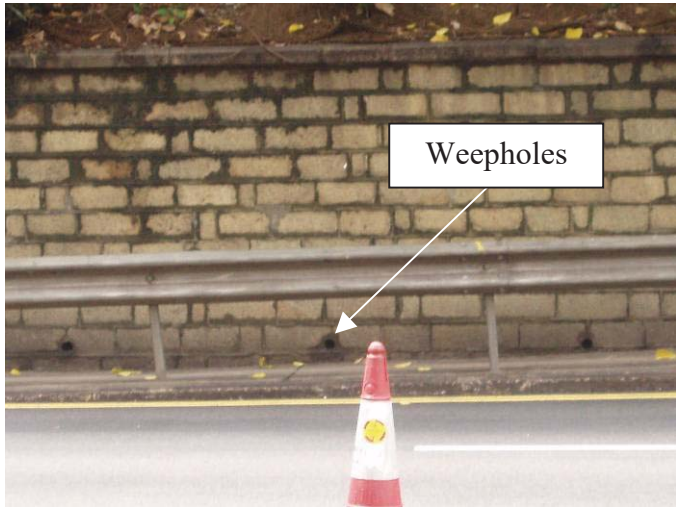
Note 3

There is no interception channel along the toe of slope but many weepholes on the retaining wall. It is expected that the stormwater runoff in Area C3 will run onto the road pavement.

No interception channel along slope toe but holes on retaining wall

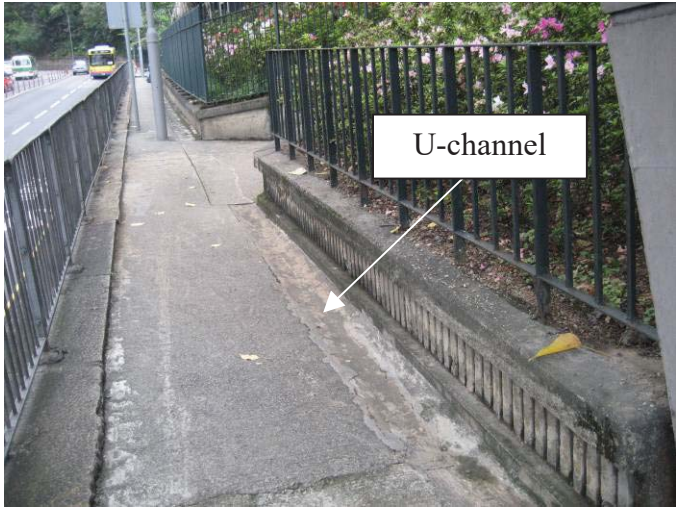
Note 4

As there is an interception channel along the toe of slope, it is expected that the stormwater runoff in Area C4 will not run onto the road pavement.

Interception channel along slope toe

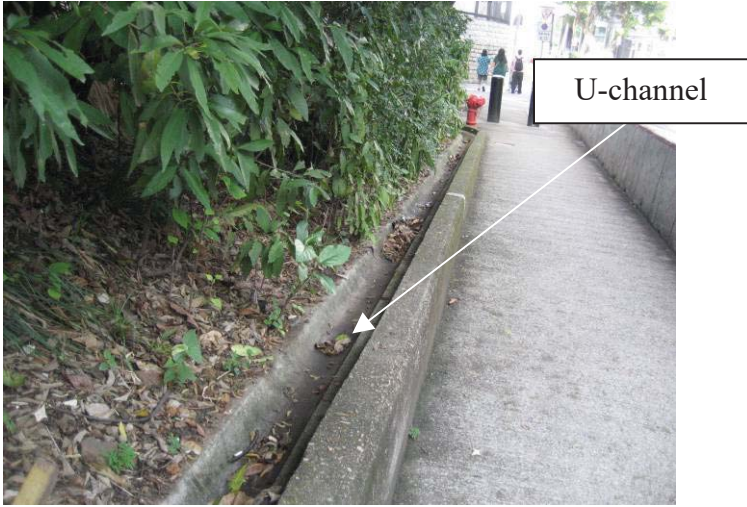
Note 6

As there is an interception channel along the toe of slope, it is expected that the stormwater runoff in Area C6 will not run onto the road pavement.

Interception channel along slope toe

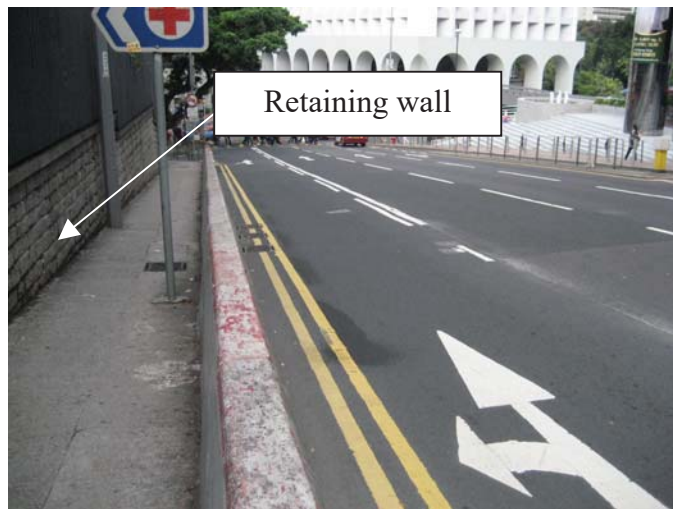
Note 7

There is a retaining wall at the toe of slope. It is expected that the stormwater runoff in Area C7 will likely be blocked by the retaining wall and will not run onto the road pavement.

Retaining wall at slope toe

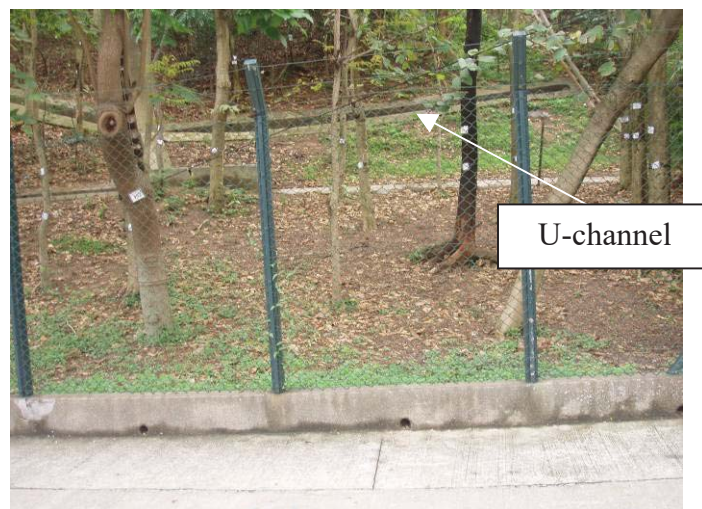
Note 8

There is an interception channel at mid-way of Area C8 but no interception channel along the toe of slope, it is expected that portion of the stormwater runoff on this area will run onto the road pavement.

Interception channel at mid-way but not along slope toe

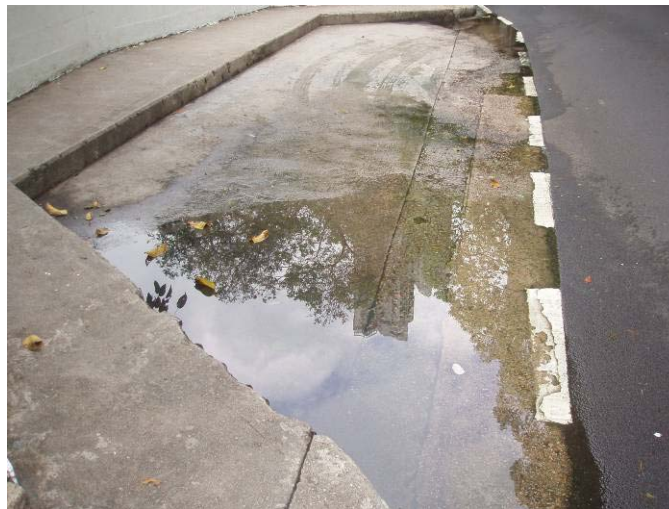
Note 10

There is no gully or channel at the lay-by. Flooding will occur at there.

No gully or channel at lay-by

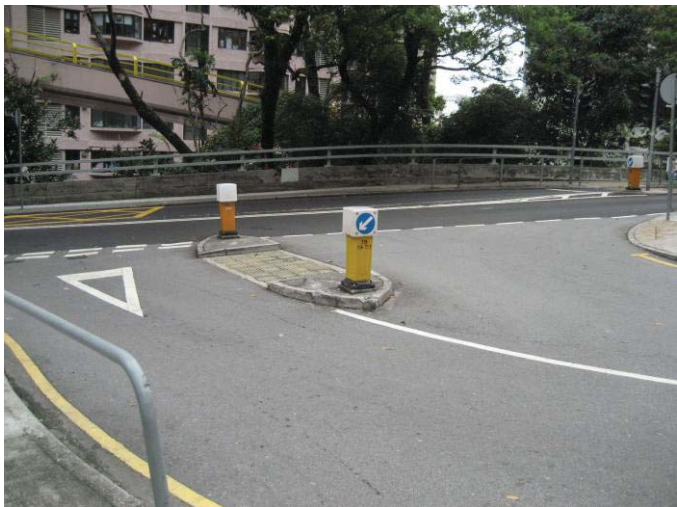
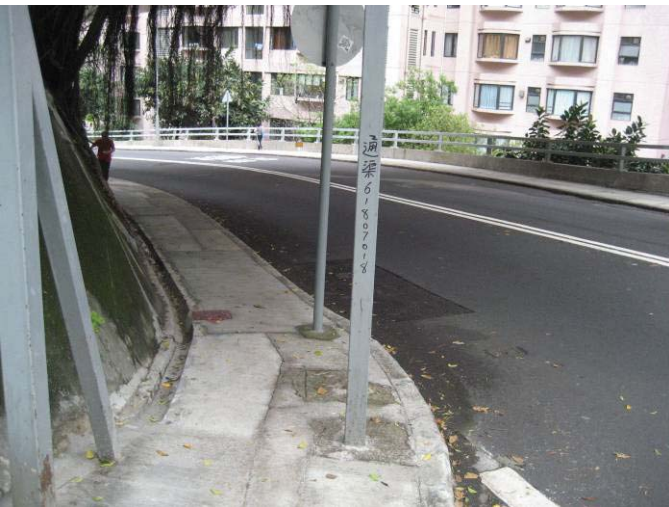
Note 11

There is no gully near the junction. Stormwater runoff from the branch road (Brewin Path) will run onto the road pavement.

No gully near junction

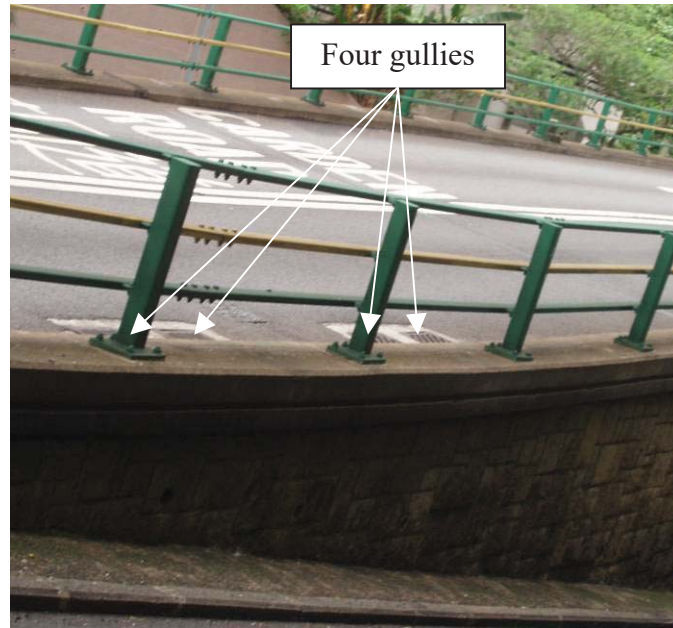
Note 13

There is a sag point at the road section at the junction with the elevated road and four gullies are provided at there.

Multiple gullies at sag point

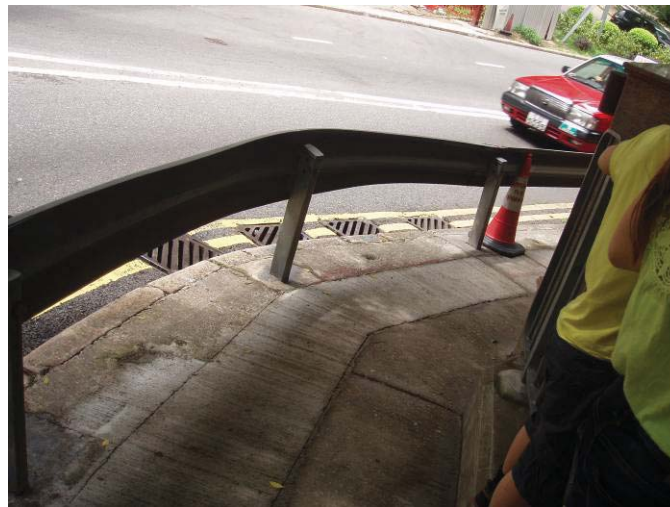
Note 15

There are four gullies at the kerb opposite to junction.

Multiple gullies at kerb opposite to the junction

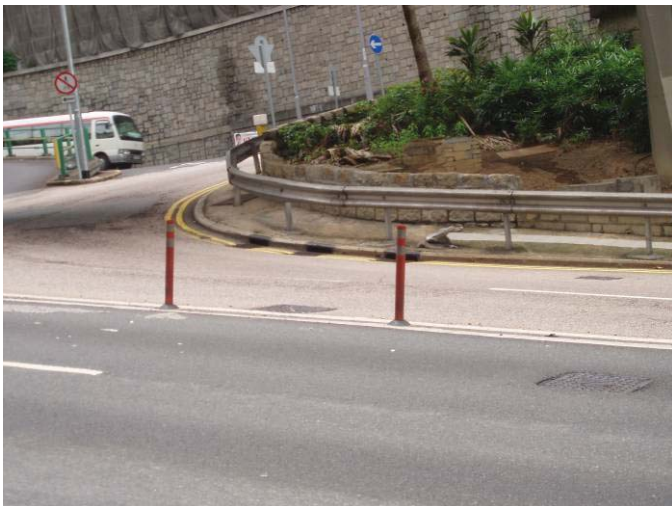
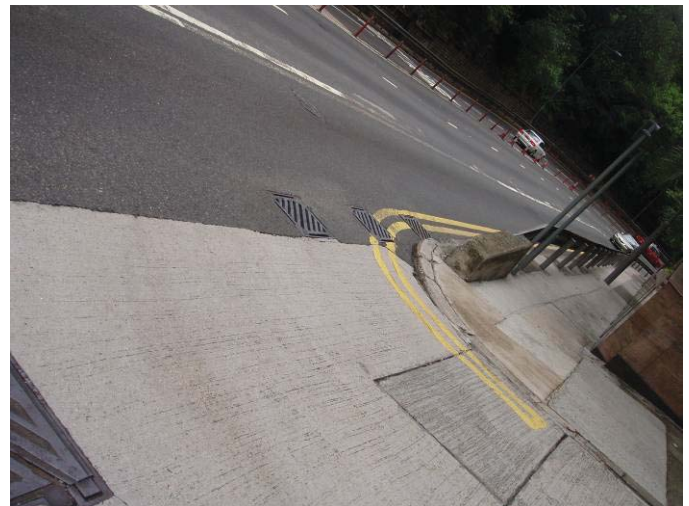
Note 16

There are six gullies near the junction.

Multiple gullies near the junction

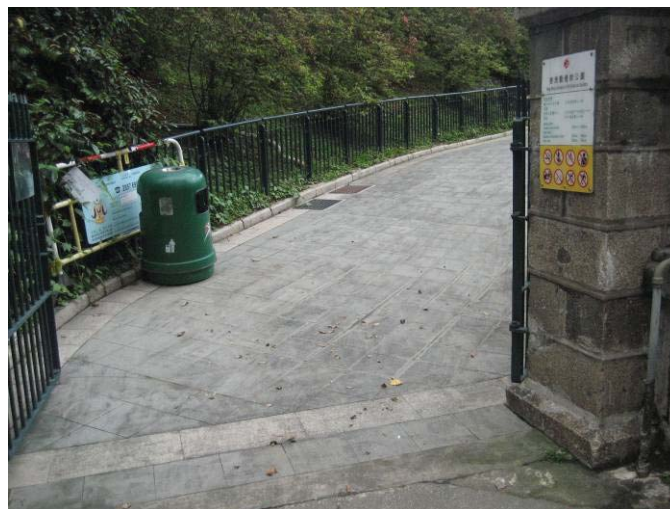
Note 18

There is no interception channel at this entrance/exit of the park. It is expected that portion of stormwater runoff in the park will run onto the pavement through the entrance/exit.

No interception channel at entrance/exit

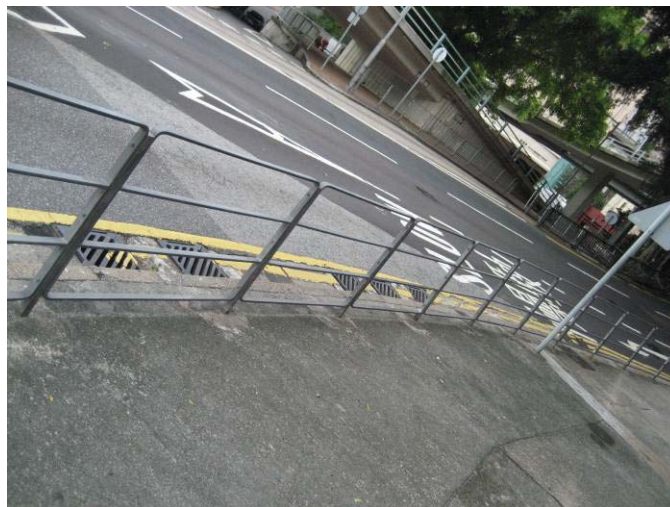
Note 20

Multiple gullies are provided at sag point/junction with branch road.

Multiple gullies at sag point/junction

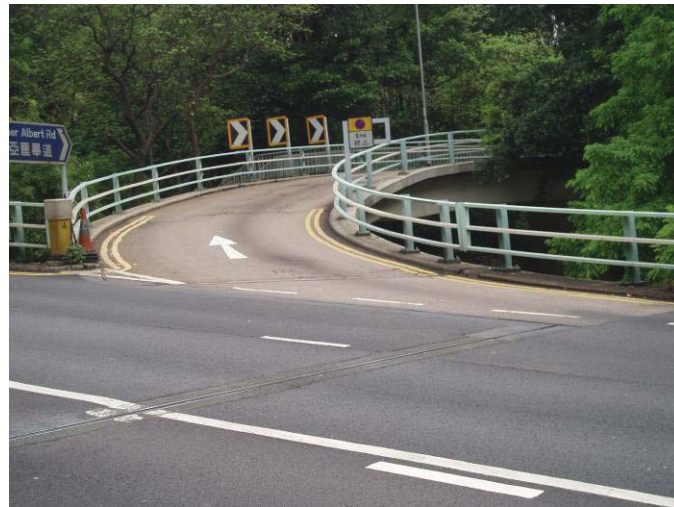
Note 21

There is no gully near the junction.

No gully near the junction

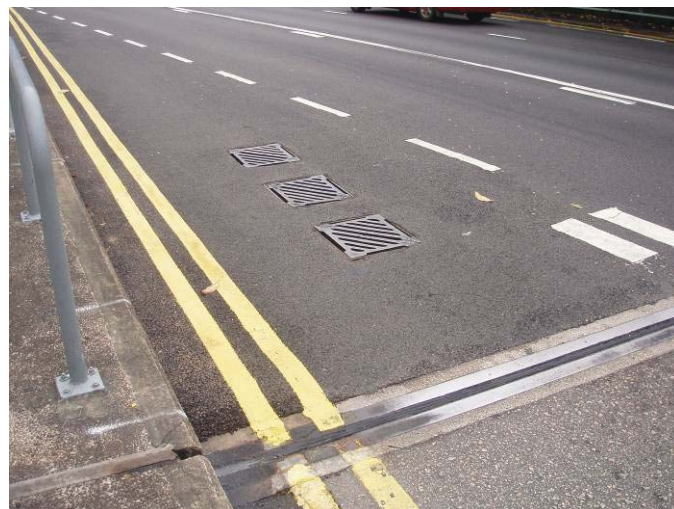
Note 22

Gullies are not provided at kerb but at middle of the lane. The interception efficiency may be lowered than that presented in RD/GN/035

Gullies provided at middle of the lane

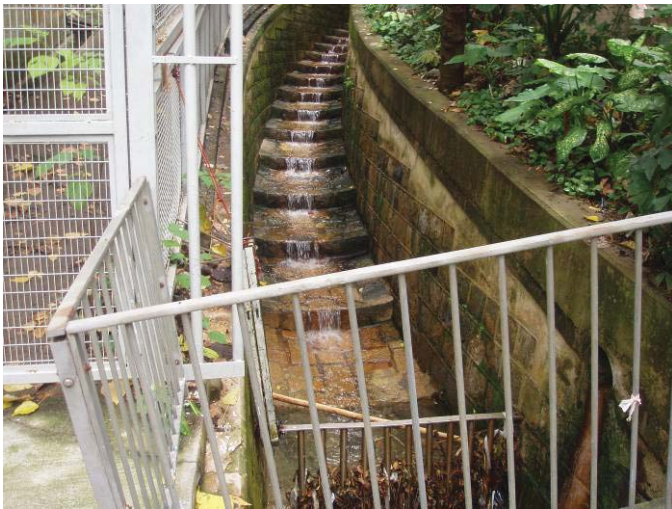
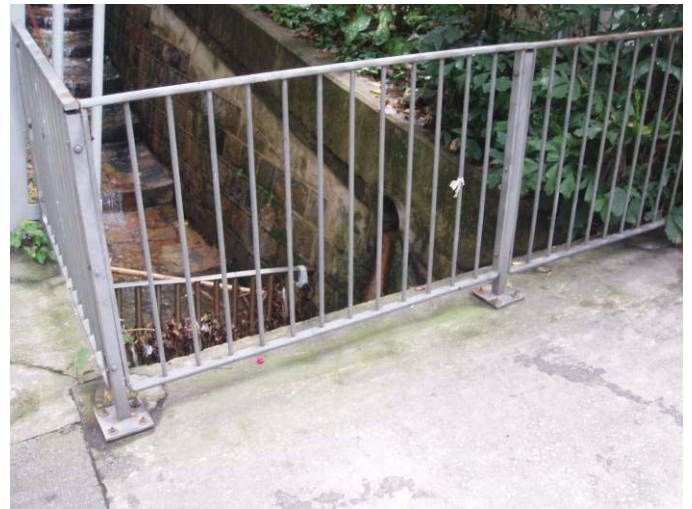
There is a large size watercourse in the vicinity. If the intake is blocked by rubbishes or debris, significant amount of stormwater runoff can overflow from the watercourse and cause serious flooding at downstream road pavement.

Large size watercourse in vicinity

3. For large watercourses running towards roads, regular desilting and maintenance for the sections of watercourses near the roads is suggested to avoid overflow of stormwater runoff from the watercourses onto the road pavements due to blockage (see Note 23 in “Notes for GR & CTD-Stage 2.pdf”).

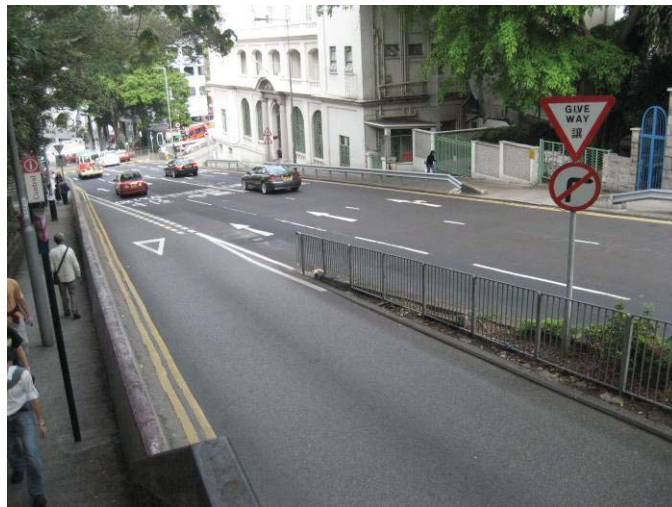
Note 24

There is no gully near the junction.

No gully near the junction

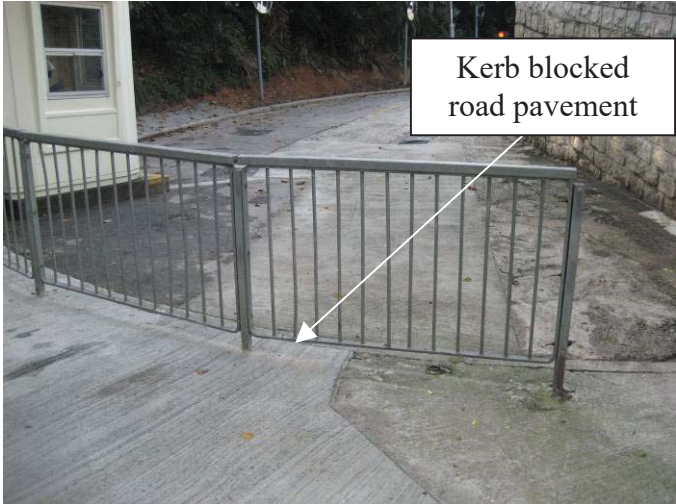
Note 25

The road pavement is blocked by kerb. Stormwater runoff on the road pavement is collected by the gullies adjacent to the kerb.

Kerb blocked road pavement

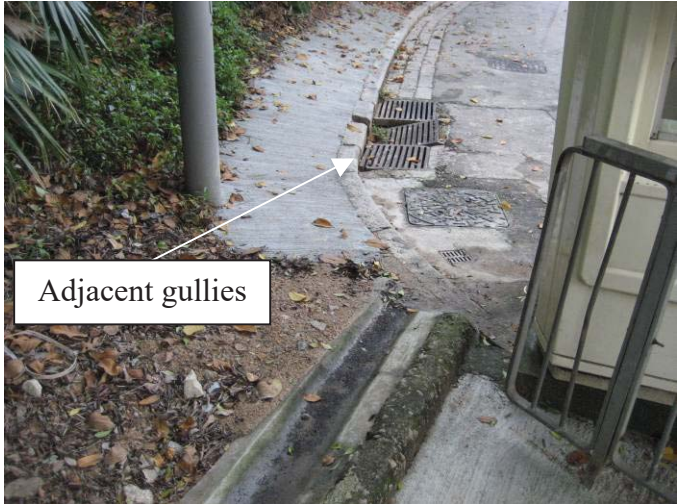
Adjacent gullies

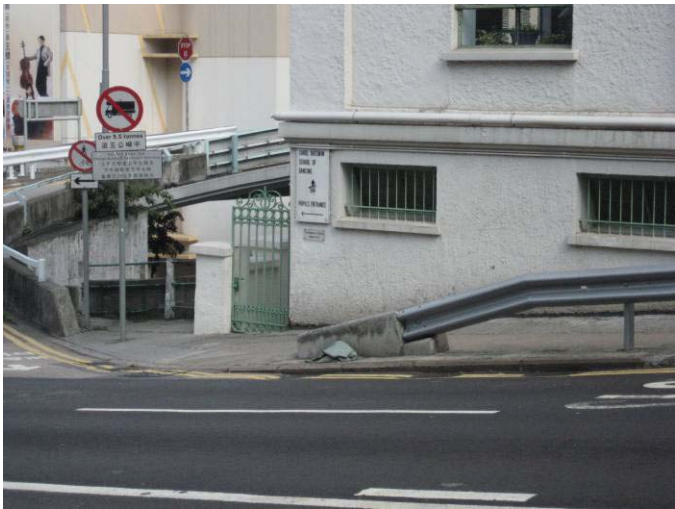
Note 26

Multiple gullies are provided at junction with branch road.

Multiple gullies at junction

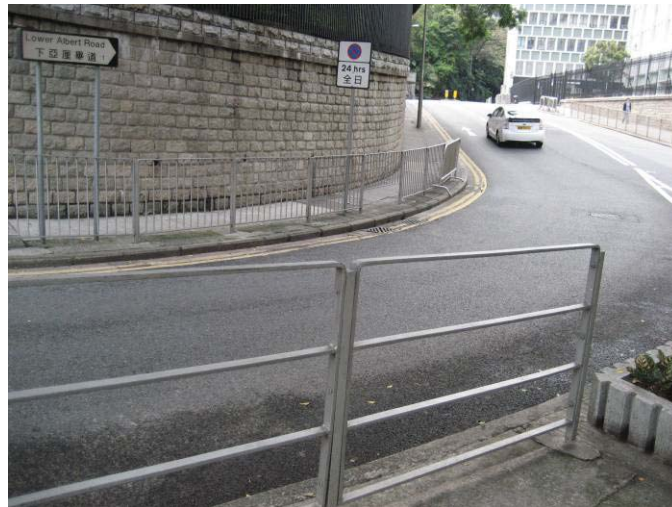
Note 27

Multiple gullies are provided at junction with branch road/sag point.

Multiple gullies at sag point/junction

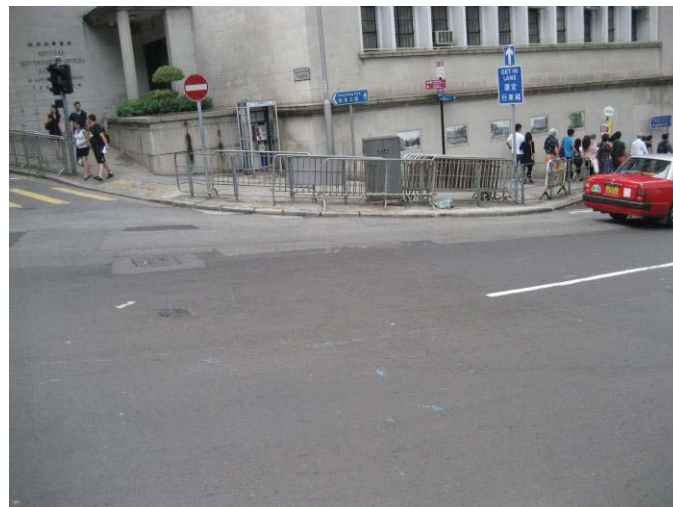
Note 28

There is no gully near the junction with branch road.

No gully near the junction

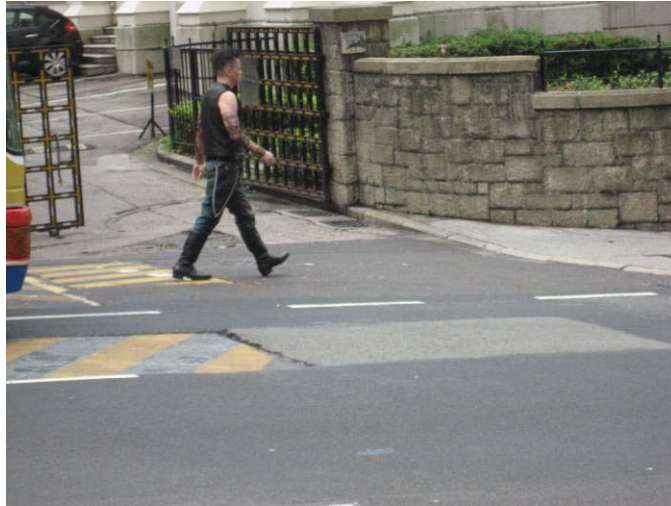
Note 29

There are double gullies at entrance/exit of the development.

Double gullies at entrance/exit of the development

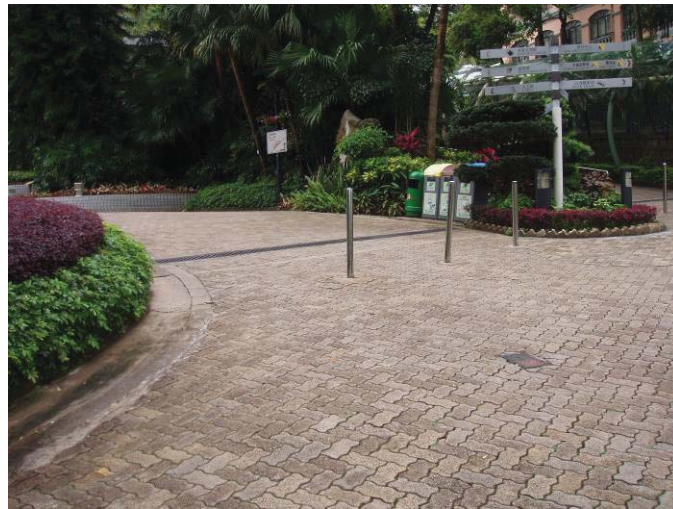
Note 31

There is a U-channel at entrance/exit of the park.

U-channel at entrance/exit of the park

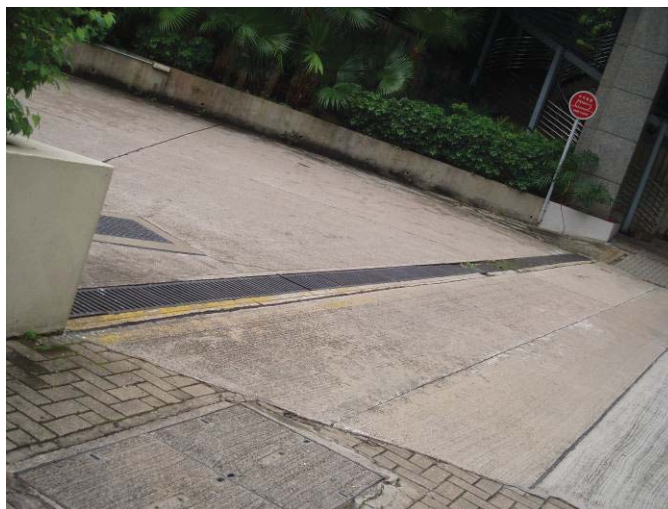
Note 32

There is a U-channel at entrance/exit of the fire station.

U-channel at entrance/exit of the fire station

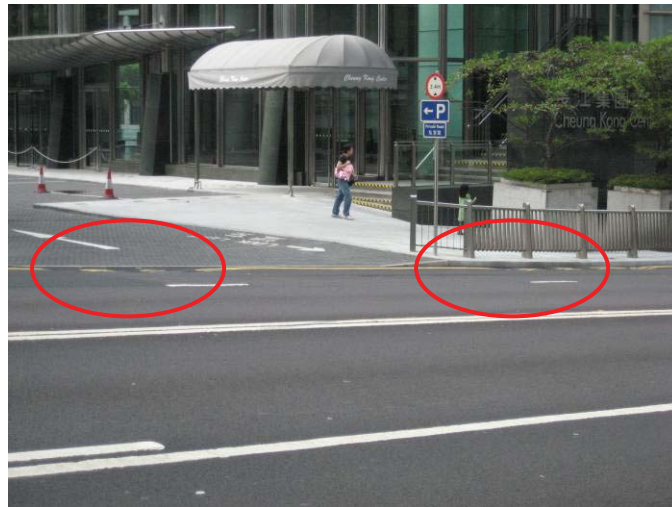
Note 33

Multiple gullies are provided at entrance/exit of the development.

Multiple gullies at entrance/exit of the development

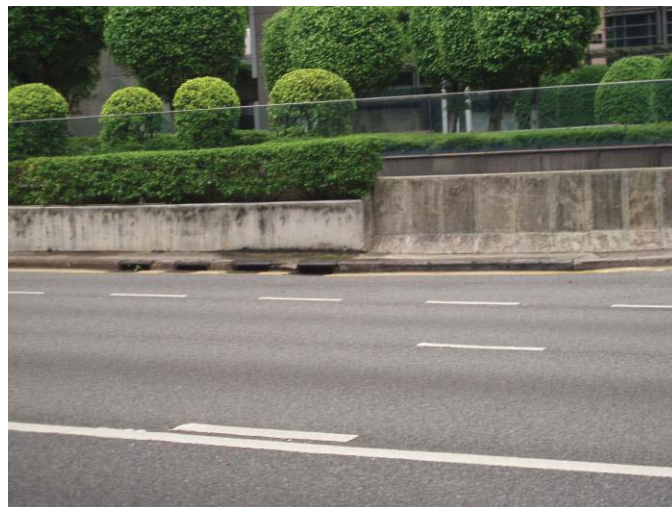
Note 34

Multiple gullies are provided near the junction with branch road

Multiple gullies near junction

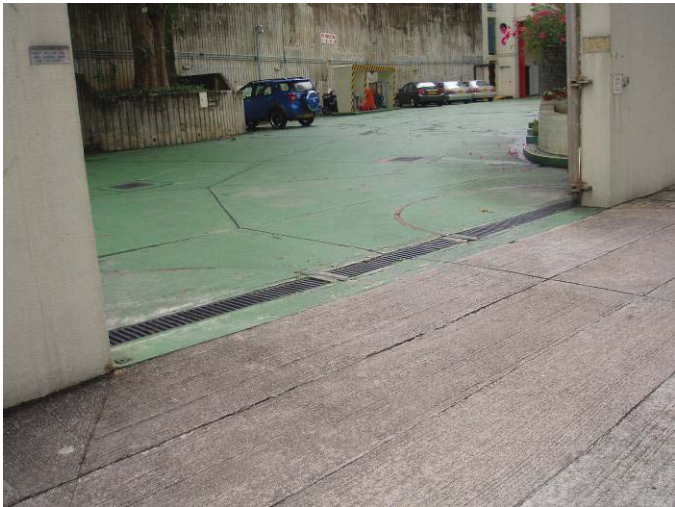
Note 35

There is a U-channel at another entrance/exit of the fire station.

U-channel at another entrance/exit of the fire station

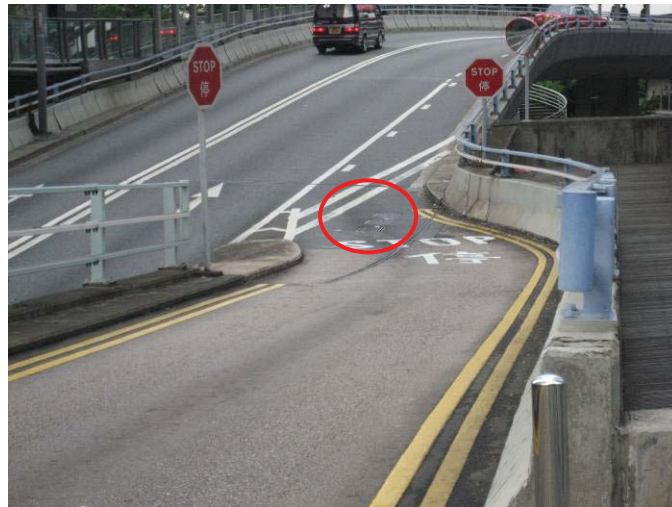
Note 37

Gullies are not provided at kerb but at middle of the lane. The interception efficiency may be lowered than that presented in RD/GN/035.

Gullies provided at middle of the lane

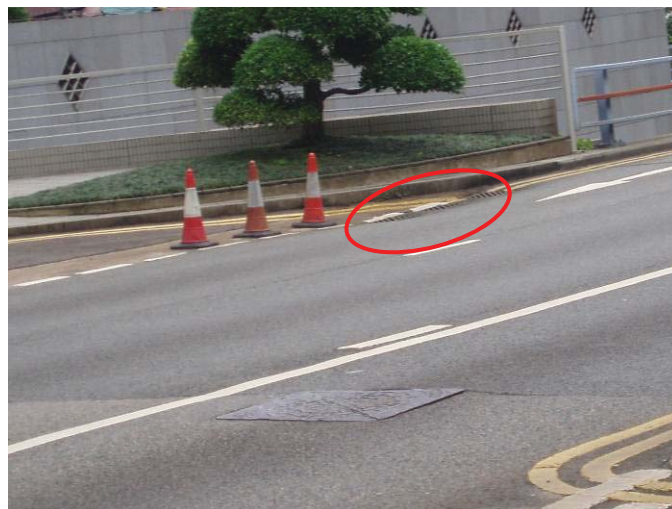
Note 38

Multiple gullies are provided near the junction with branch road.

Multiple gullies near junction

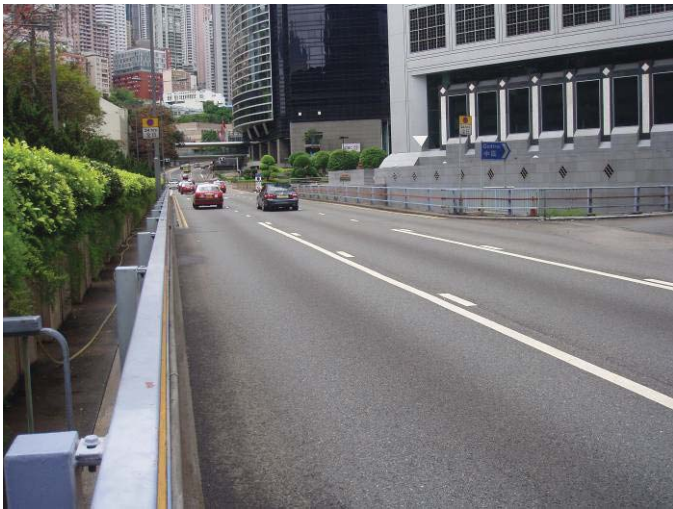
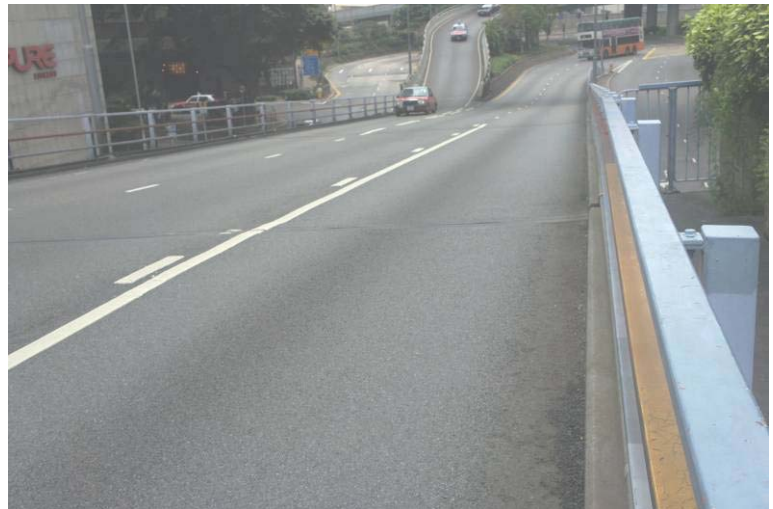
Note 39

There is no gully on a long section of the road pavement.

No gully on a long section of road pavement

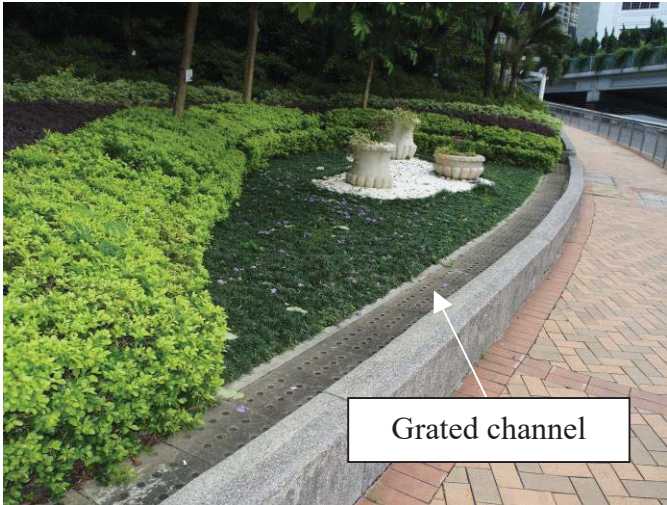
Note 47

There is an interception channel along the toe of the slope. It is expected that no stormwater runoff from the slope will run onto the pavement.

Interception channel along slope toe

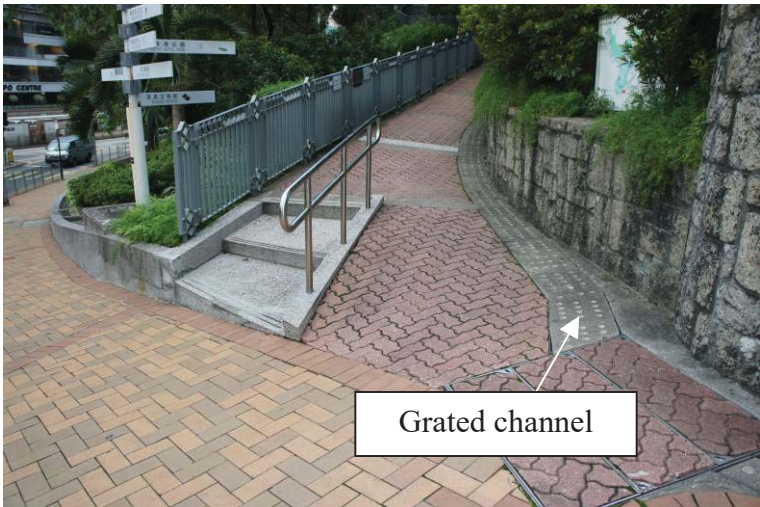
Note 48

There is an interception channel next to the entrance/exit of the park. It is expected that no stormwater runoff from the park will run onto the pavement.

Interception channel at entrance/exit

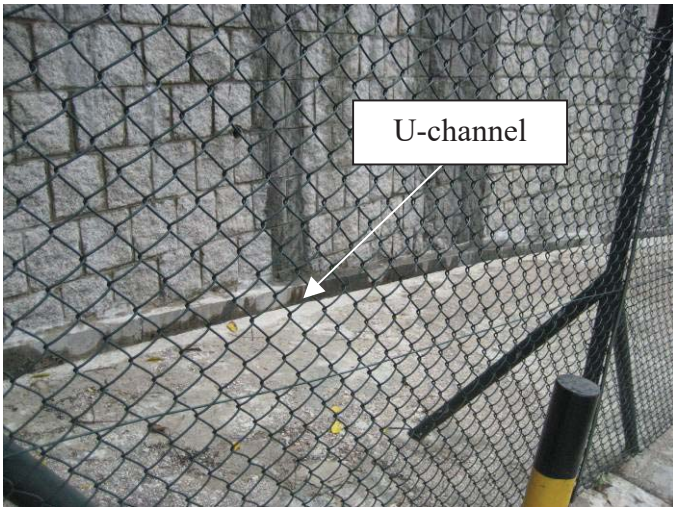
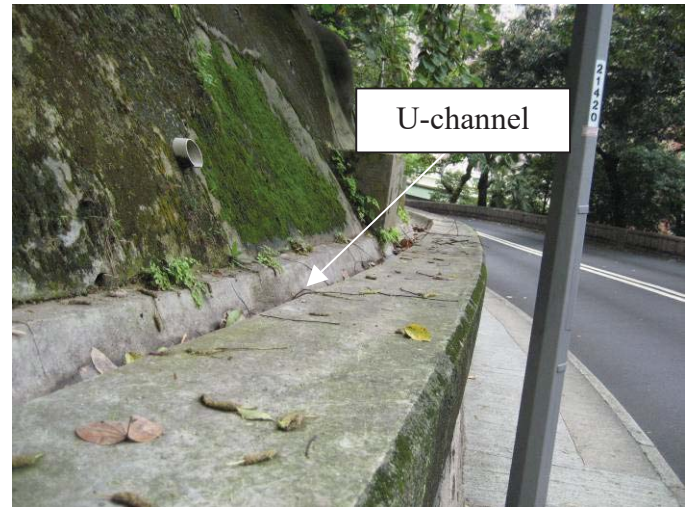
Note 1

As there is an interception channel along the toe of slope, it is expected that the stormwater runoff in Area C1 will not run onto the road pavement.

Interception channel along slope toe

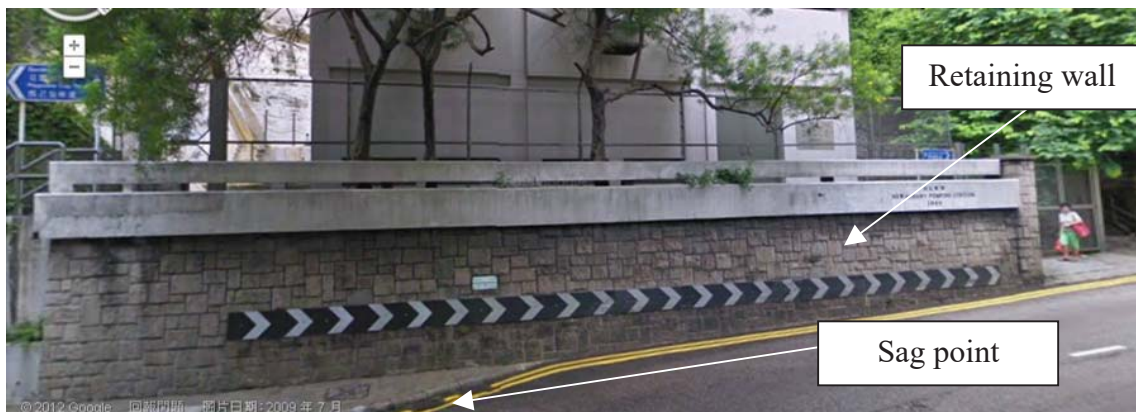
Note 2

There is a retaining wall at the toe of slope. It is expected that the stormwater runoff in Area C2 will likely be blocked by the retaining wall and will not run onto the road pavement. Besides, there is a sag point at the road section immediately next to the retaining wall and six gullies are provided at there.

Retaining wall and multiple gullies

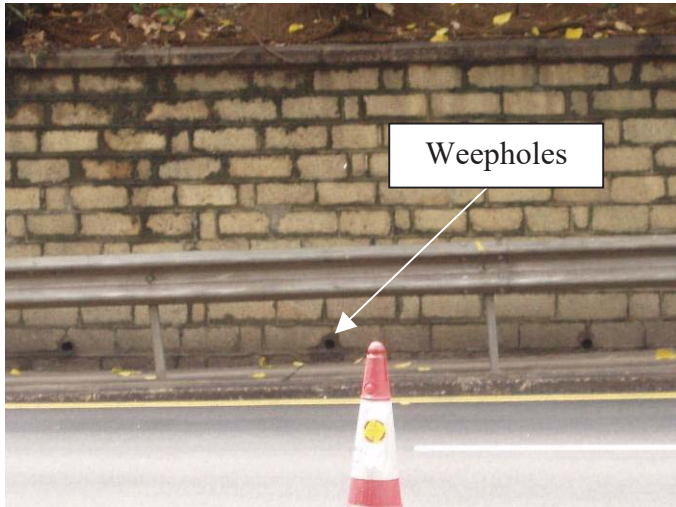
Note 3

There is no interception channel along the toe of slope but many weepholes on the retaining wall. It is expected that the stormwater runoff in Area C3 will run onto the road pavement.

No interception channel along slope toe but holes on retaining wall

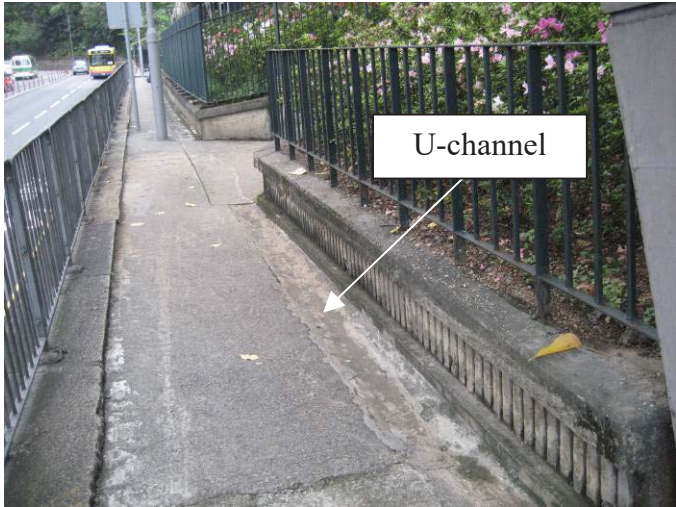
Note 4

As there is an interception channel along the toe of slope, it is expected that the stormwater runoff in Area C4 will not run onto the road pavement.

Interception channel along slope toe

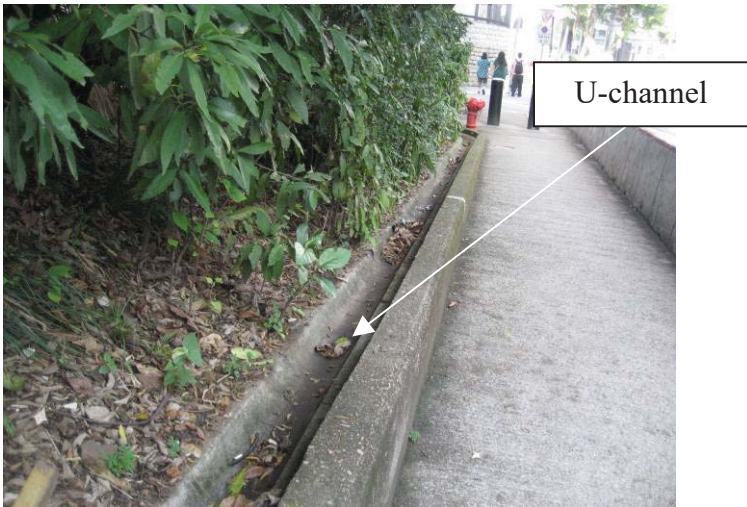
Note 6

As there is an interception channel along the toe of slope, it is expected that the stormwater runoff in Area C6 will not run onto the road pavement.

Interception channel along slope toe

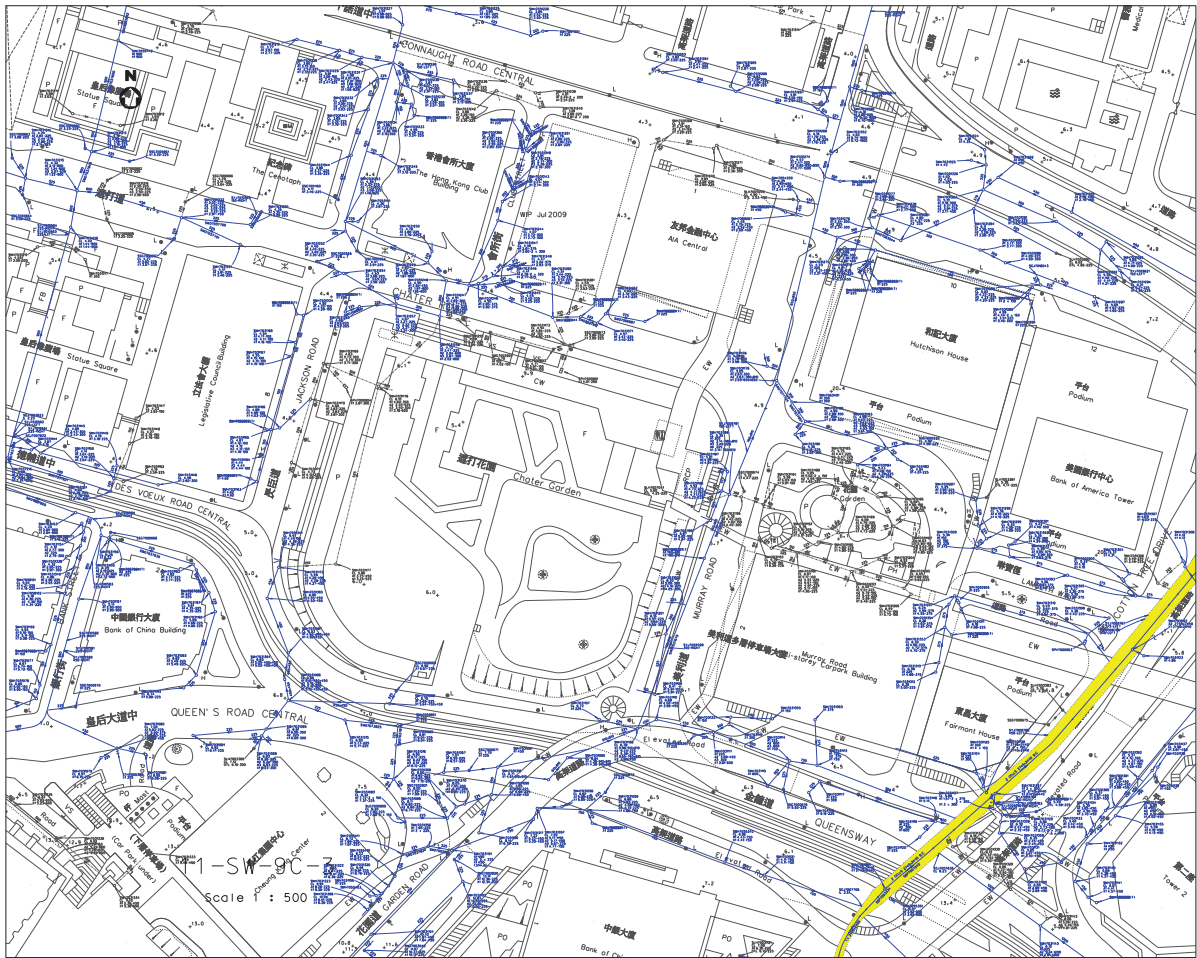
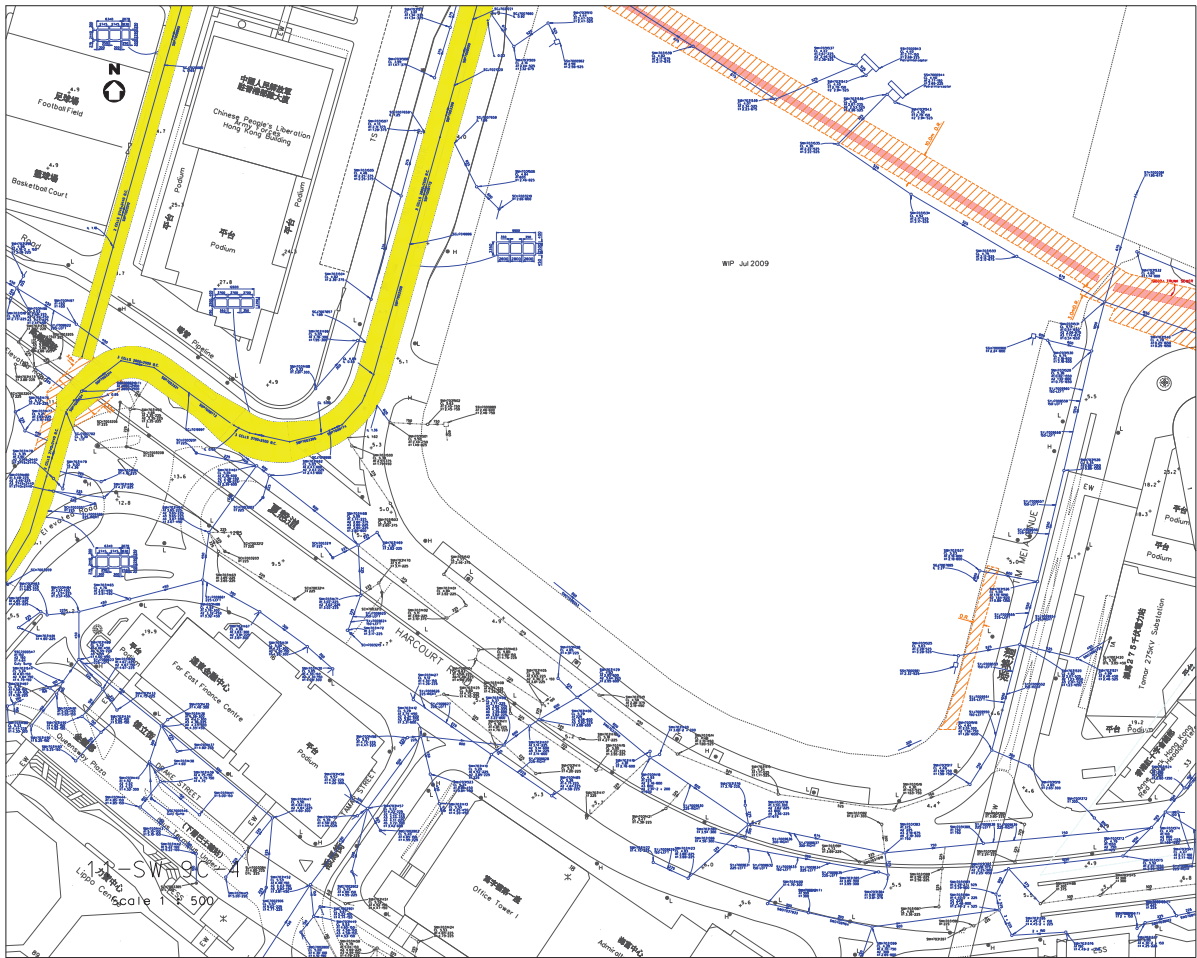
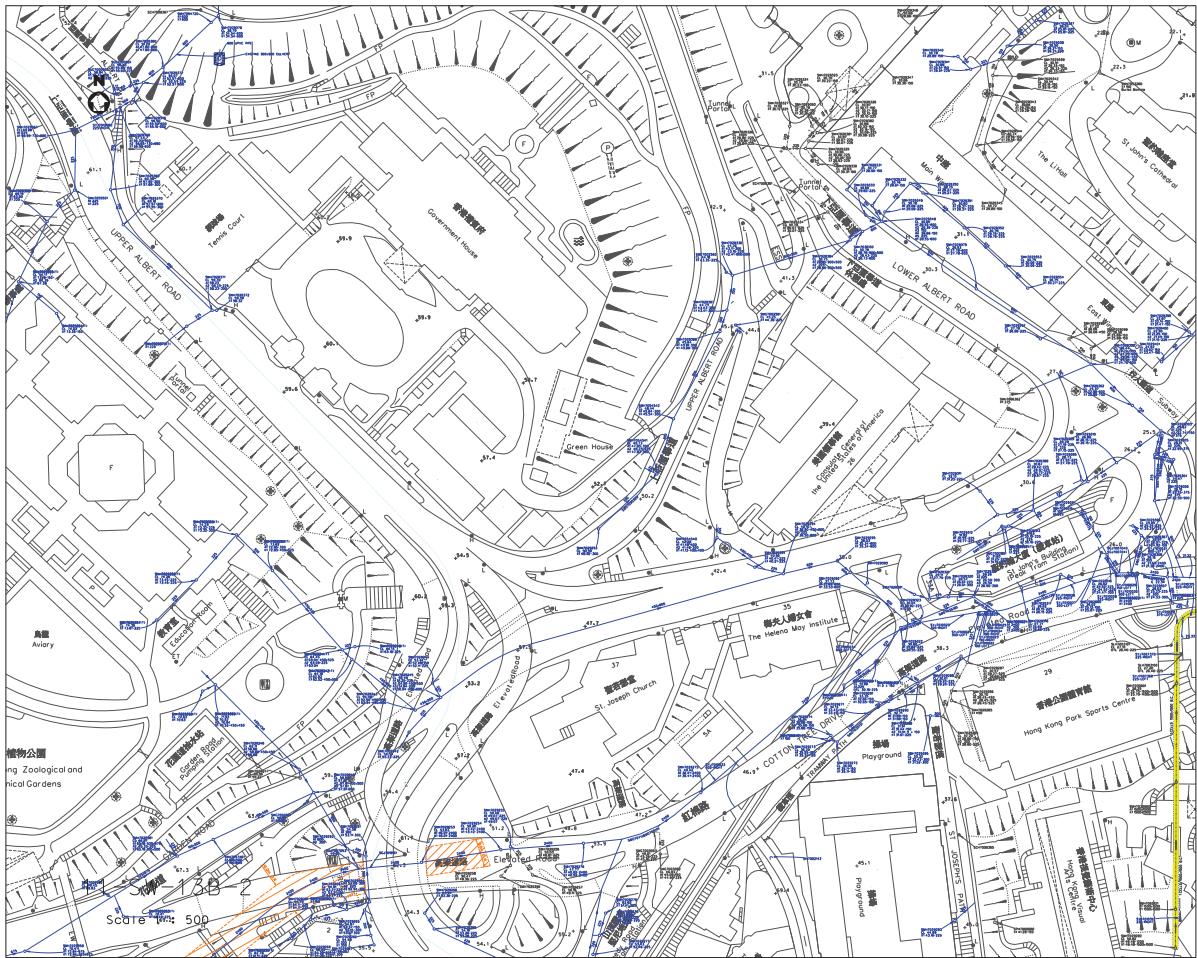
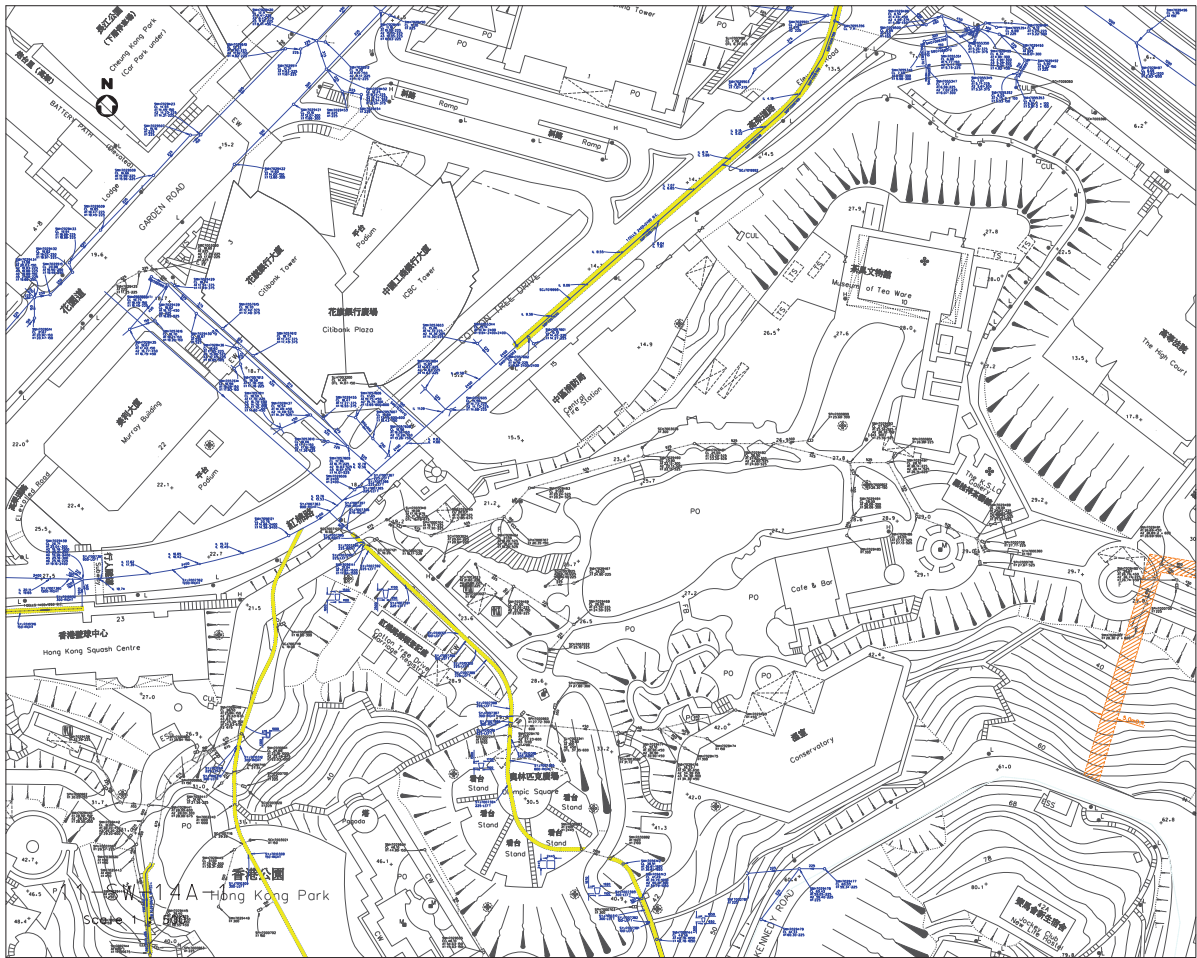
Adequacy of Drains 1 - 9 & 11-14

For Drains 1–9 and 11–14, it appears that they may not be exclusively for the concerned road sections and upland catchments but may also convey stormwater runoff from some other catchments. Therefore, it is not certain whether they are adequate to convey the stormwater from the concerned road sections and upland catchments (i.e. Road Areas 1 – 9 & 11 – 13 and Areas C3, C5 and C8) even though their capacities may be larger than the stormwater runoff from the concerned road sections and upland catchments. In such situation, it is recommended to consult DSD to acquire their advice and findings from their relevant drainage studies. For this DIA, DSD has provided their advice on whether Drains 1 – 9 and 11 – 12 are adequate to handle the stormwater runoff under a 1 in 50 year rainfall intensity based on their past Drainage Master Plan study in the Northern Hong Kong Island. (please refer to “Adequacy of Drains 1–9 and 11–14.pdf”).

Node No.	Flood Depth (m)	Node No.	Flood Depth (m)	Pipe Size (mm)	Handle 50 Yrs Design Storm ?
Drain 1	SMH7048886	0.105	SGJ7013053	0	300	No
Drain 2	SMH7029358	0	SMH7029361	0.121	525 x 675	No
Drain 3	SMH7029253	0	SMH7029254	0	2400	Yes
Drain 4	SMH7029308	0	SMH7029438	0	2400	Yes
Drain 5	SMH7029420	0.102	SMH7031104	0.101	450	No
Drain 6	SGJ7019992	0	SMH7055356	0.147	2400 x 2400	No
Drain 7	SMH7031357	0	SMH7031122	0	2745 x 2440	Yes
Drain 8	SMH7031122	0	SMH7031480	0	2745 x 2440	Yes
Drain 9	SMH7031130	0	SMH7031358	0	450	Yes
Drain 11	SMH7029500	0	DownStream	0.134	450	No
Drain 12	SMH7031101	0.101	SMH7031317	0	450	No
Drain 13	SMH7031096	no record *	SMH7031091	no record *	450	-
Drain 14	SMH7031316	no record *	SMH7031089	no record *	225	-

# Please note that the above figures are *for information only*. All records are extracted from the past DMP Study submitted by Consultants, pipe network in the model may be not updated and not tallied with existing drainage record.
