**Investigation Report on  
Prestressing Tendon Failure Incident at  
Concrete Viaduct of Shenzhen Bay Bridge  
- Hong Kong Section**

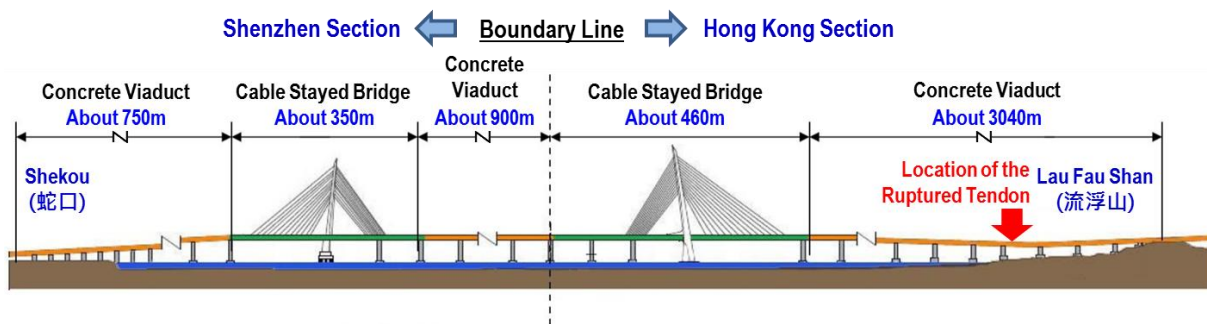
Figure 4 Location of Ruptured Tendon

1.3.3 During a routine site inspection on 15 February 2019, a HyD site staff discovered an external prestressing tendon at the concrete viaduct of SBB-HK Hong Kong bound being ruptured. The location of the ruptured tendon is shown in Figure 4.

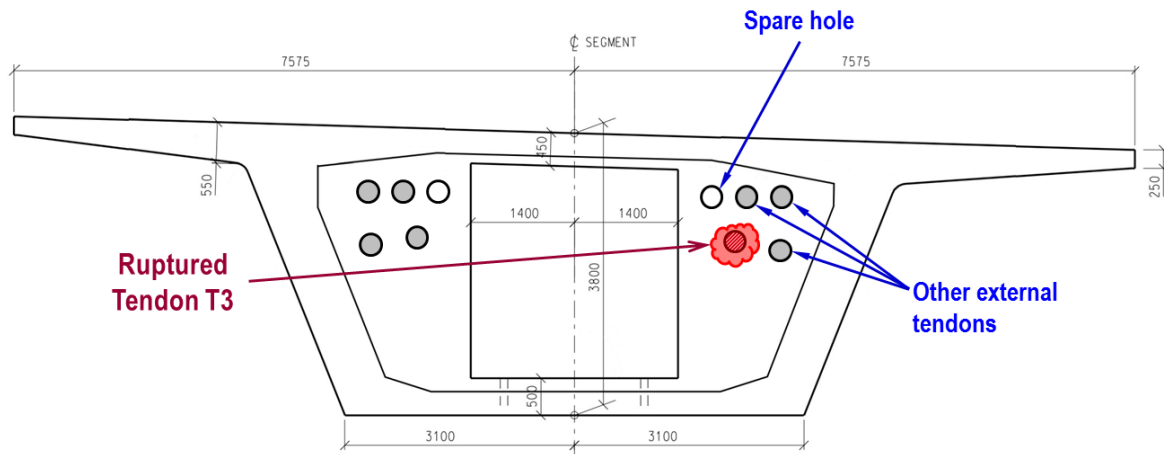
Figure 8 End view at Pier P5 with Location of Ruptured Tendon T3

1.3.6 The bridge deck structure of Bridge B2 is 15m wide with a single-cell trapezoidal box girder section of 3.8m deep. A cross section and photo of the bridge deck at Pier P5 where Tendon T3 ruptured are shown in Figures 8 and 9, and the typical anchorage details of the tendon at anchorage is shown in Figure 10.

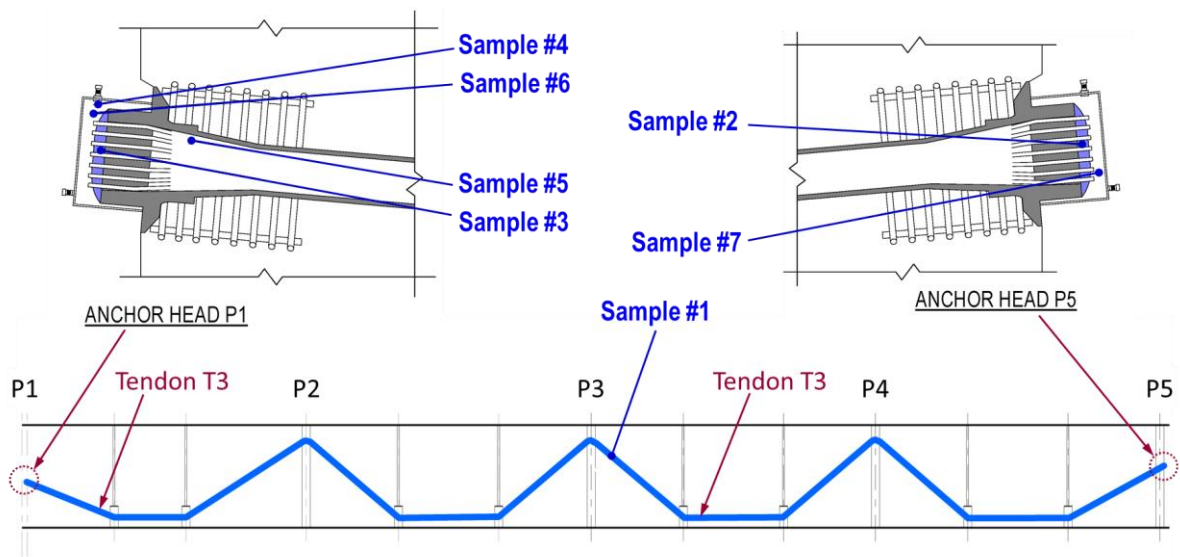
Figure 23 Locations of grout samples taken for SEM analysis

- 3.1.11 According to the site records retrieved, the grout had been tested at the time of construction and confirmed to meet the specification requirements for strength and segregation.
- 3.1.12 The Investigation Team conducted chemical tests on grout samples collected at the ruptured tendon and the anchor heads. The test results showed that the chloride content satisfied the specification while the pH values were around 12 to 13.5, right within the standard values of cement. The test results did not indicate any sign of corrosion inducing element contained in the grout material.
- 3.1.13 Samples of grout material were also collected from different locations by the Investigation Team as shown in Figure 23 for examination in SEM. No abnormality was identified from the SEM analysis of the grout samples. Detailed results and analysis of the grout samples are presented in **Appendix A**.

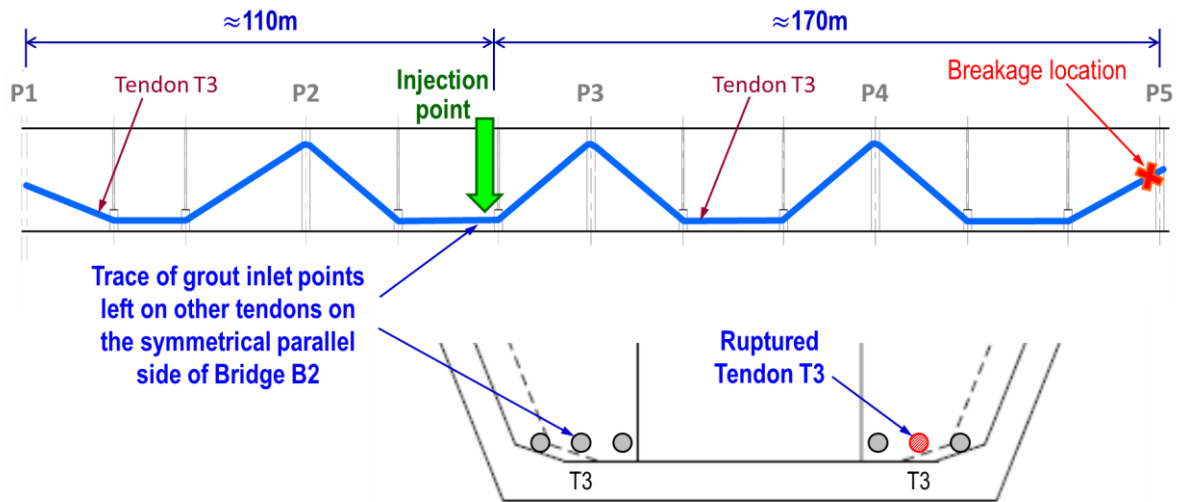
**Figure 25 Trace of grout Injection point at Tendon T3**

3.3.6 Based on the trace of grout injection points left on the other tendons and VSL's advice provided after a joint site inspection with the Investigation Team, the Investigation Team considered that the grout injection point for Tendon T3 was located at the low point in-between Piers P2 and P3. Such grout injection point was located at about 110m from anchor head P1 which is at about 170m from anchor head P5 (See Figure 24 below).

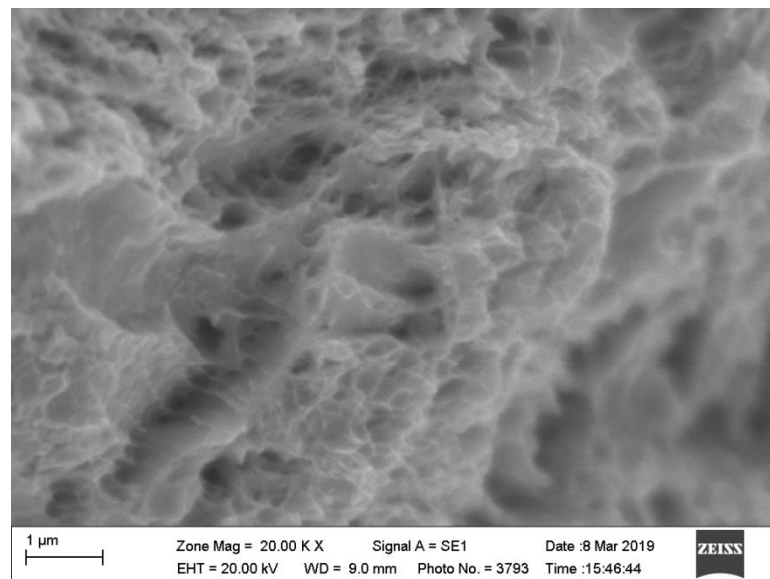
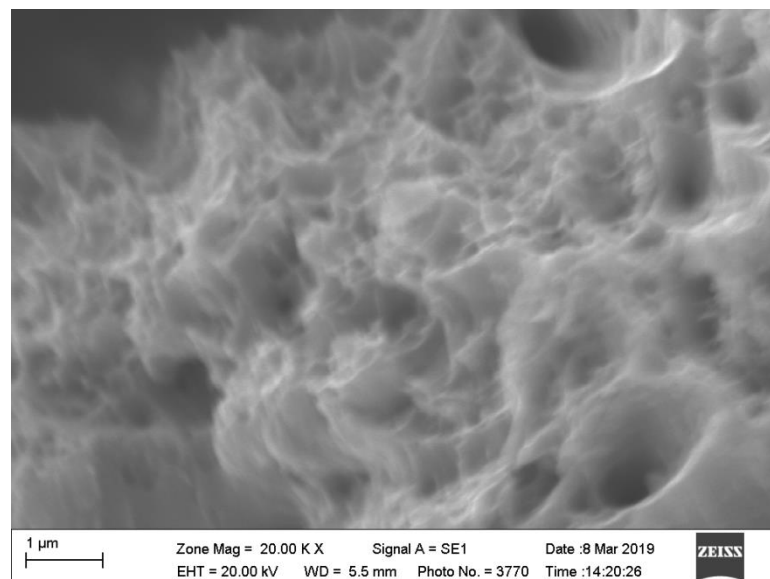
12 randomly selected wires with serious corrosion attack were examined more carefully in a Scanning Electron Microscope (SEM) to characterise their nature of failure. Despite the serious corrosion attack, the fracture surfaces on all samples examined exhibited typical dimple features that are characteristics of ductile overload failure with no signs of stress corrosion cracking. An analysis of the chemical species by an Energy Dispersive X-Ray Spectroscopy technique (EDAX) at the interface between the corroded surface and base metal also revealed no signs of any aggressive elements. Only traces of Chloride were found on one out of more than 30 points that were analysed and this was likely due to contamination to the sample after it was removed from the site.

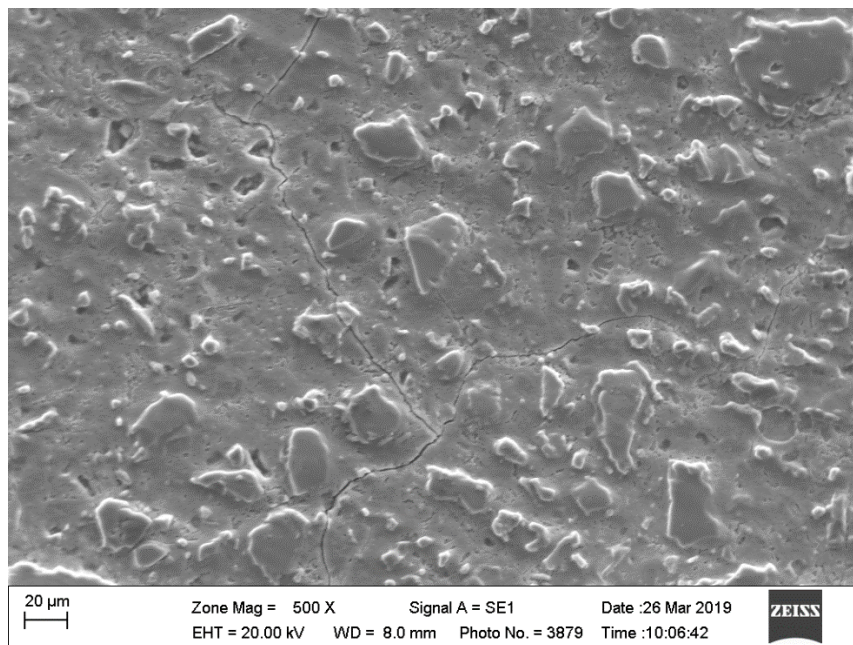
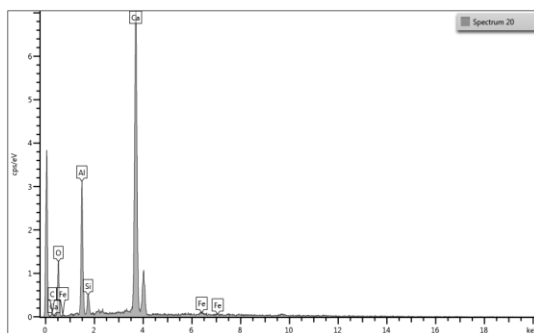
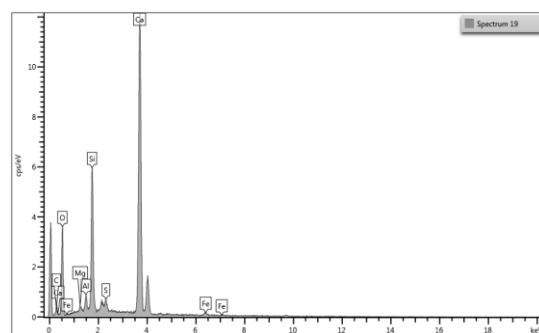
**Sample 1:** Grout sample from a section at SB37 where no signs of corrosion of the tendons were found (This sample is treated as the control sample).

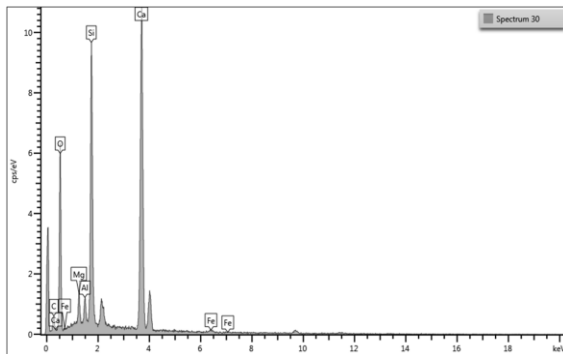
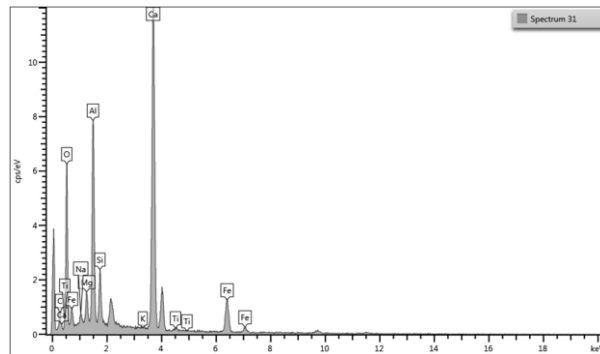
**Sample #2:** Sample from the end cap at P5, retrieved from the anchor body  
 A piece of sample from P5 Cap shows very different structure. This contained very large particles that are likely constituent of cement mortar. The matrix was simply Calcium rich cementitious material (Spectrum 30 & 31) and the large particles sands in the mortar.

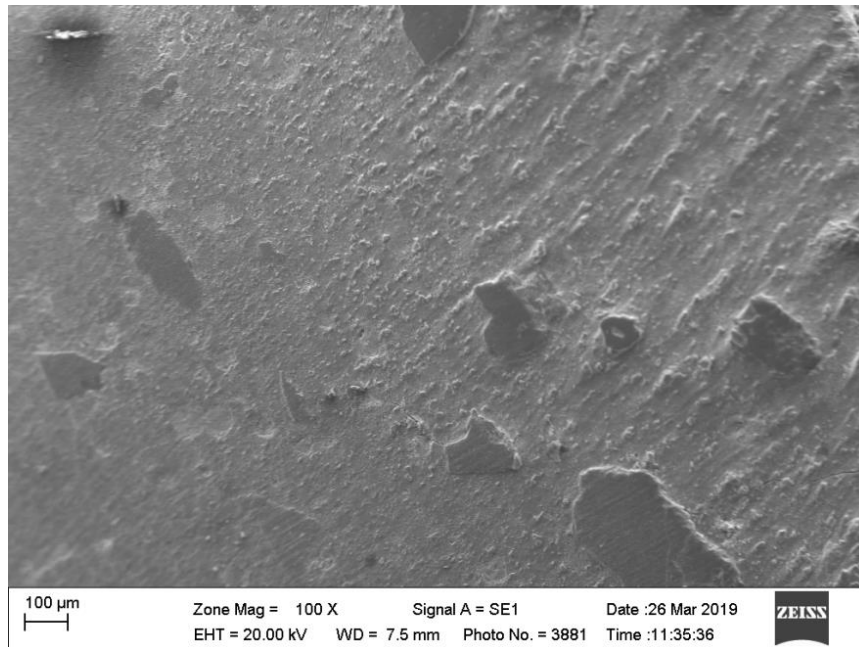
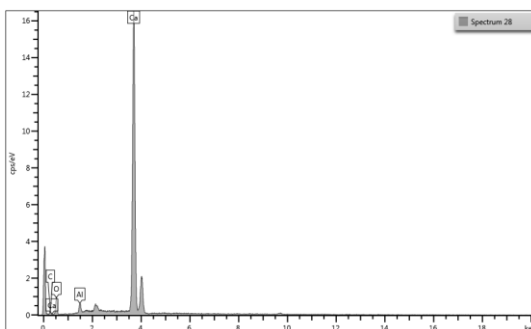
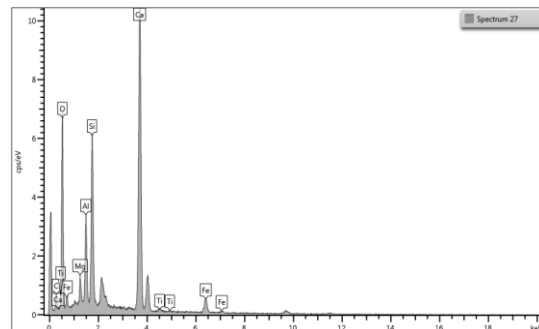
**Sample #3:** Sample from the end cap at P1, retrieved from the anchor body  
 This sample has a structure very different to the grout, and is similar to the mortar sample retrieved from the end cap of P5. The matrix was simply Calcium rich cementitious material (Spectrum 27 & 28) and the large particles sands in the mortar.

This confirmed that there was a layer of cement mortar attached to the anchor inside the end cap.

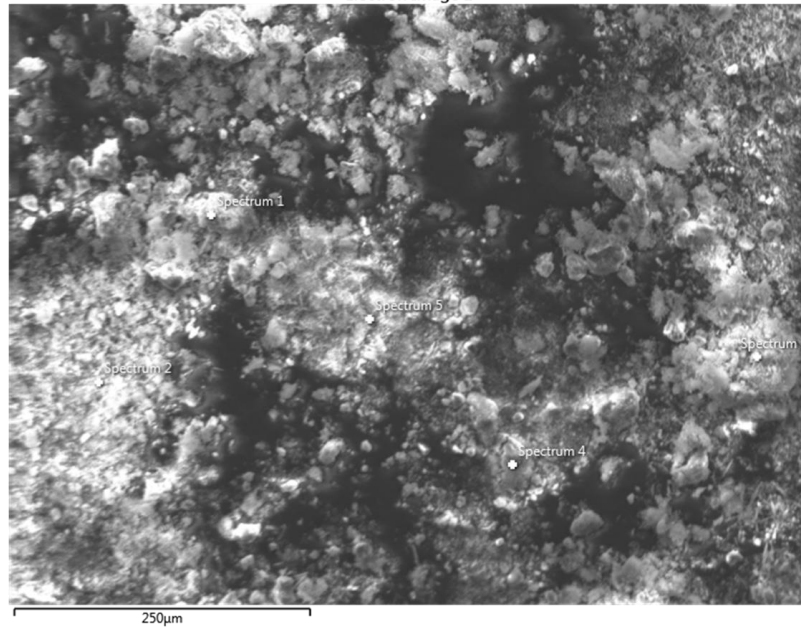
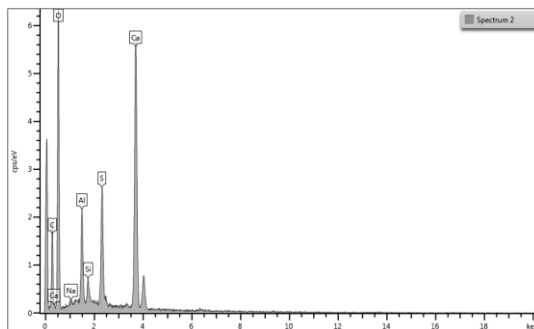
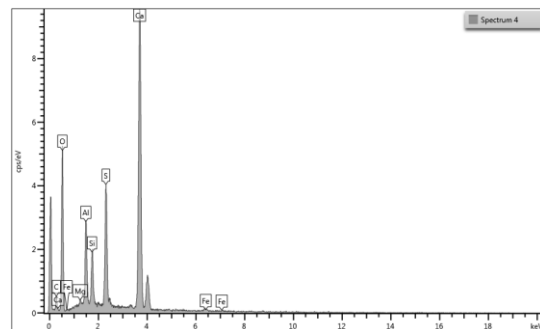
**Sample #4:** Taping of the whitish powders from the top of the End Cap of P1  
 The powders are Ca-S rich materials that are most certainly the products of bleeding which is known as laitance. No traces of Chloride were detected.

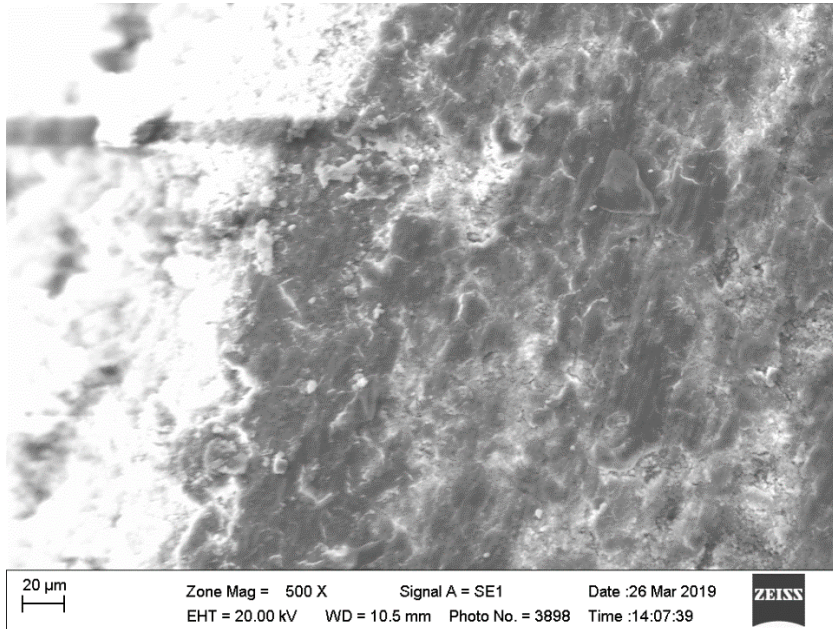
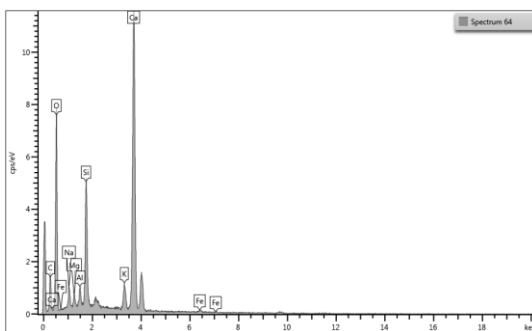
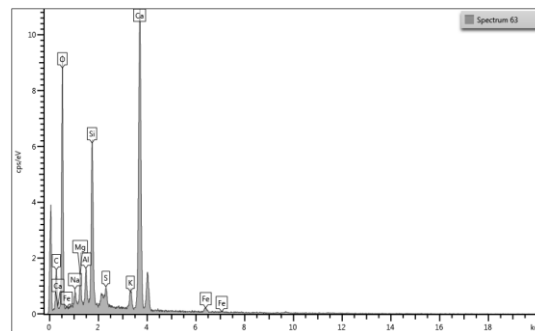
**Sample #5:** Grout Sample from the top of the End Cap of P1

An assessment was conducted along the section from the top into a block of sample, and the structure was found to vary through the thickness, from laitance (white powder), into a structure that contained a lot of white curly structure (Spectrum 64) and then into a structure of more consistent grout (Spectrum 63). The white curly structure is likely formed after bleeding.

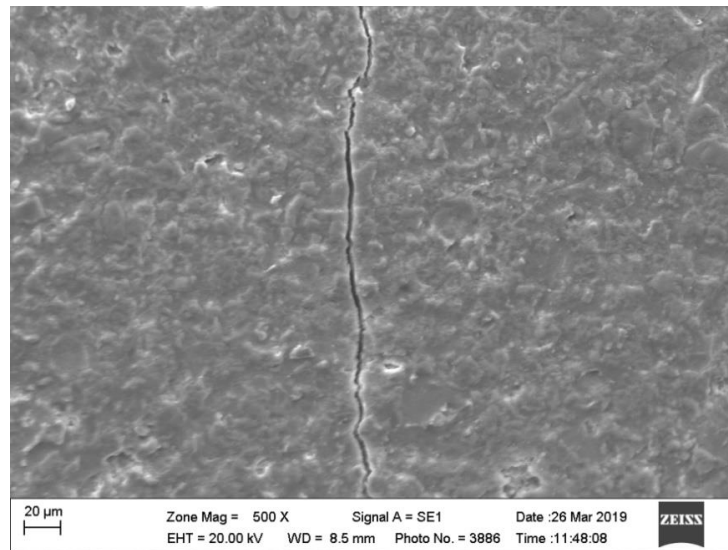
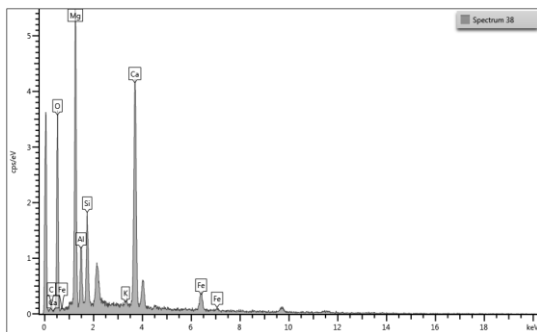
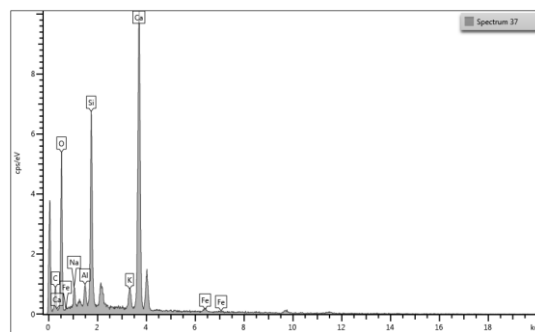
**Sample #6:** Grout sample from inside the end cap of P1

Similar to the structure of the control sample, likely to be normal grout but the Mg content appeared to be higher in the grout.

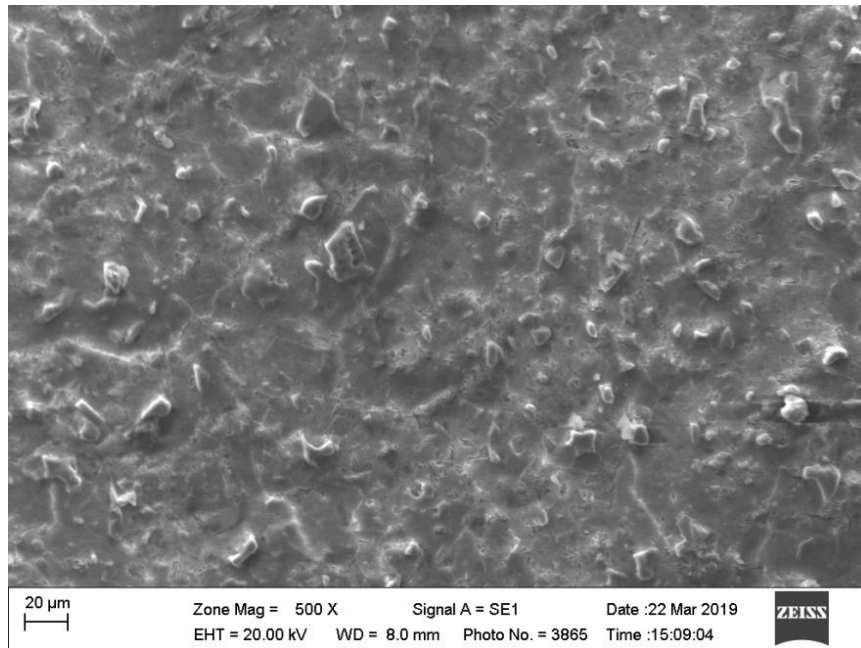
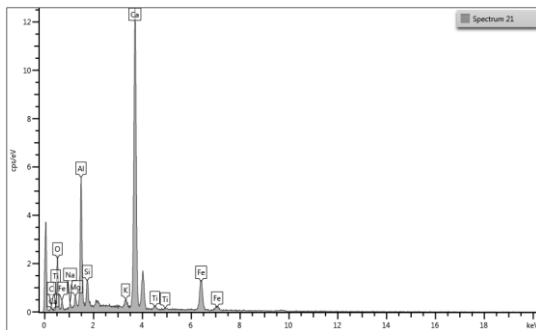
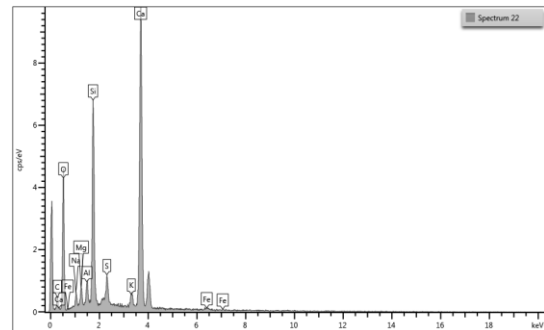
**Sample #7:** Grout sample from inside the end cap of failed end at P5

Similar to the structure of the control sample, likely to be normal grout, with limited or no signs of bleeding.
